PREPARED FOR: CITY OF METHUEN

BLOODY BROOK WATERSHED PLANNING STUDY Methuen, Massachusetts

PARE CORPORATION
10 LINCOLN ROAD, SUITE 210
FOXBORO, MASSACHUSETTS 02035

SUBMITTED JUNE 2022

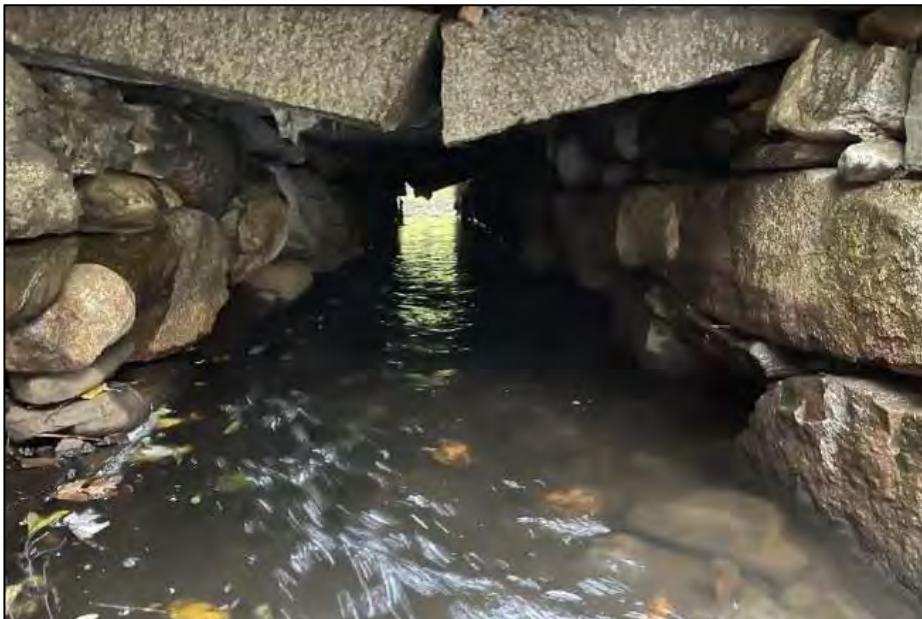
Photo No. 4.: Brook Street Crossing Upstream End – Stone Headwall is cracked and split on top but no major impediment to flow.

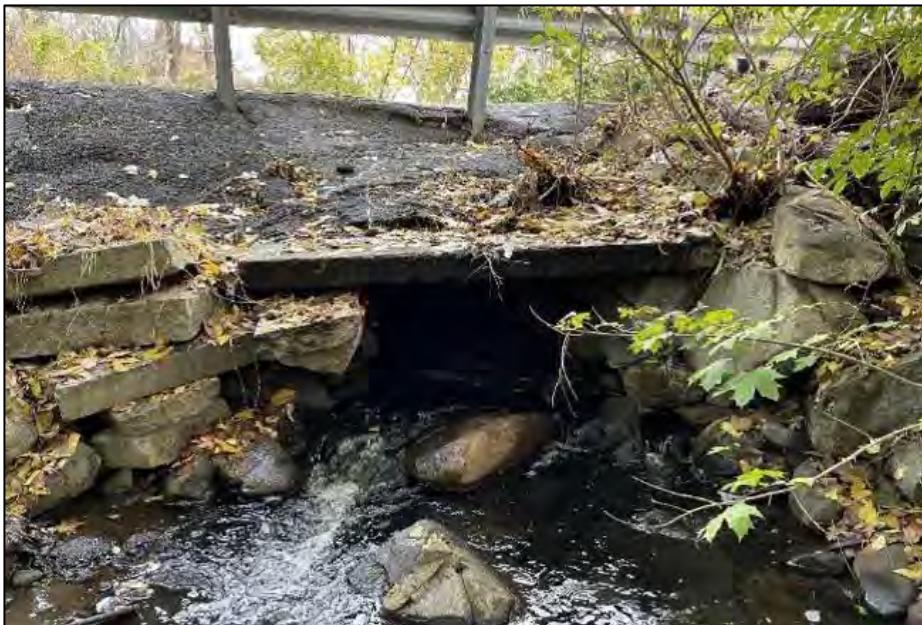
Photo No. 5.: Brook Street Crossing Downstream End – Note large stones potentially impeding the flow of the stream. Stone masonry walls are slightly deteriorated.

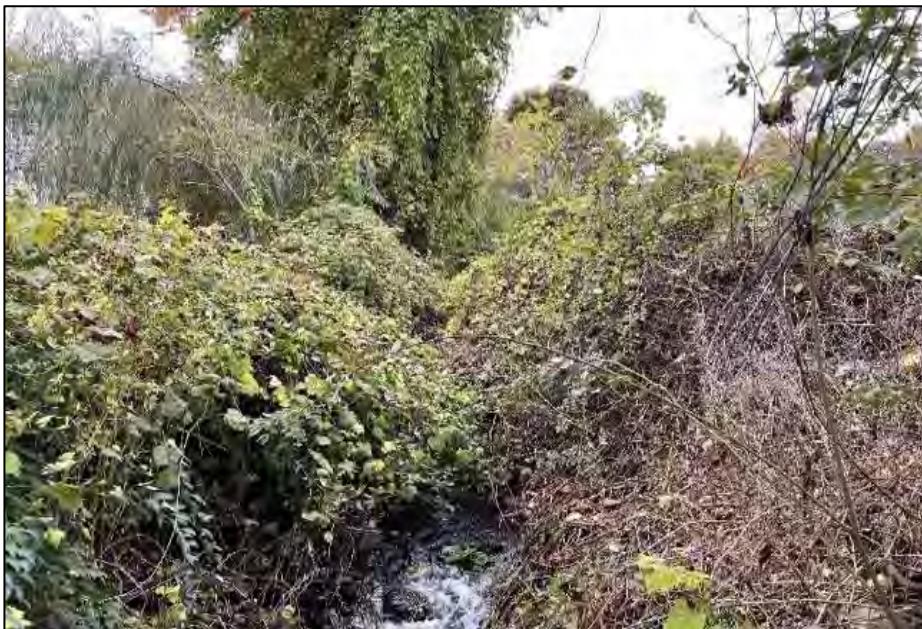
Photo No. 6.: Brooks Street – East Street Channel looking downstream. Note the extensive overgrowth of vegetation resulting in hydraulic restriction

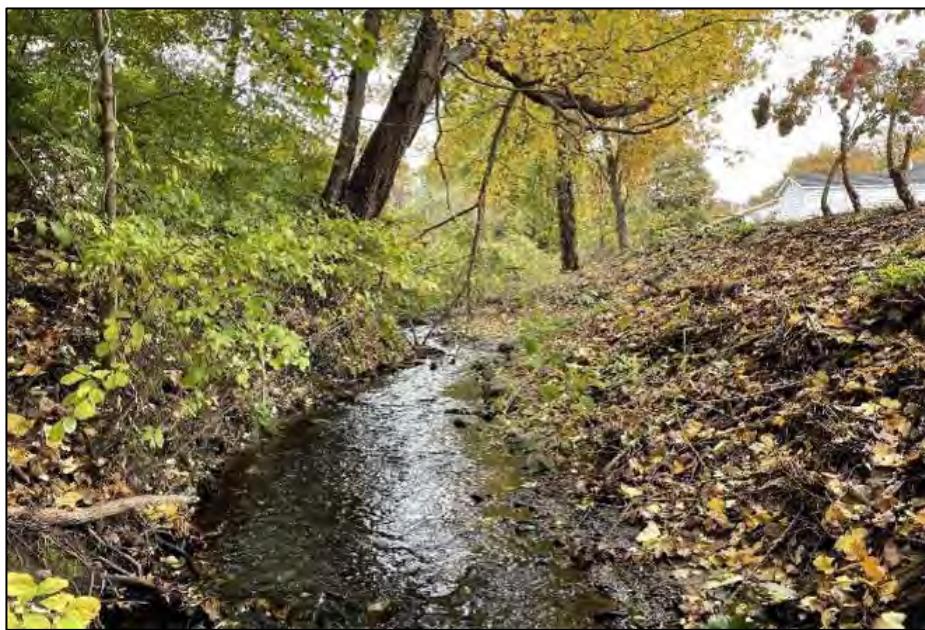
Photo No. 7.: Brooks Street – East Street Channel. Open Channel at 1/3 of the length from Brooks Street – looking downstream. Note bare unprotected banks prone to erosion.

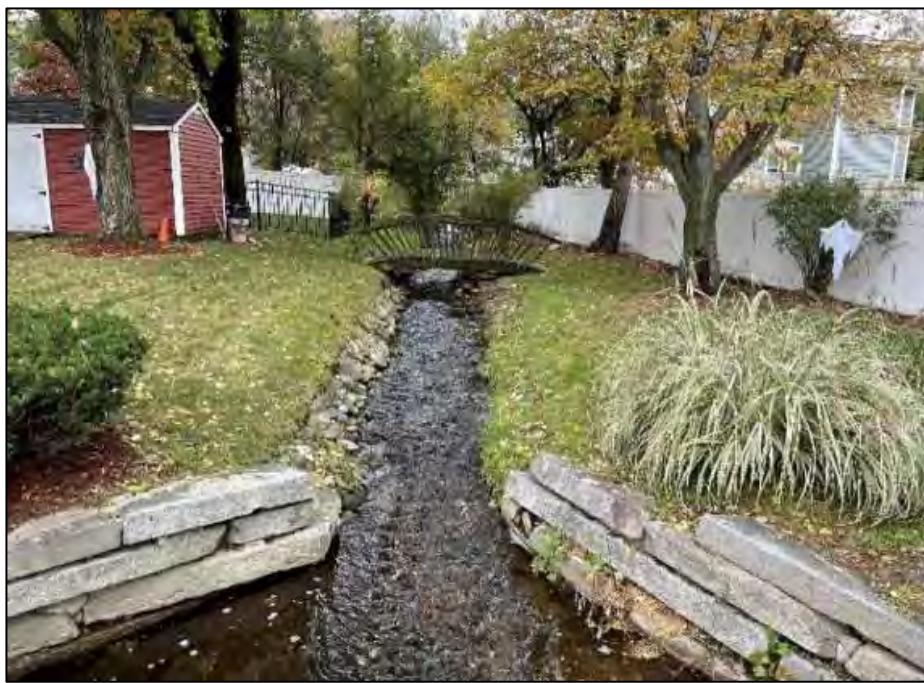
Photo No. 13.: East Street – Approach Channel. Channel is generally clear of debris but slopes to the abutments are very shallow.

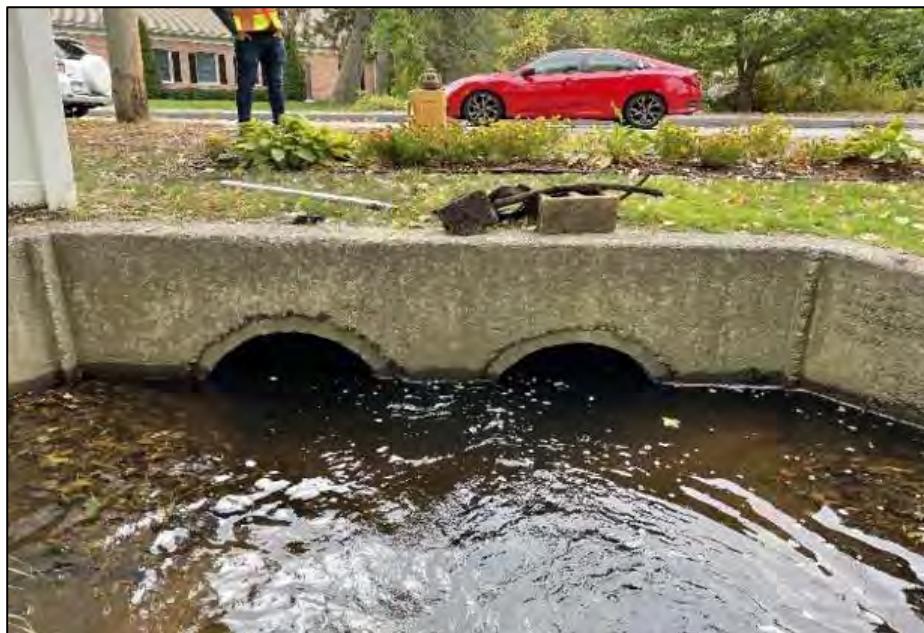
Photo No. 14.: East Street – Crossing Upstream End. Culverts are silted in about halfway and accumulates debris from the upstream end during high flows.

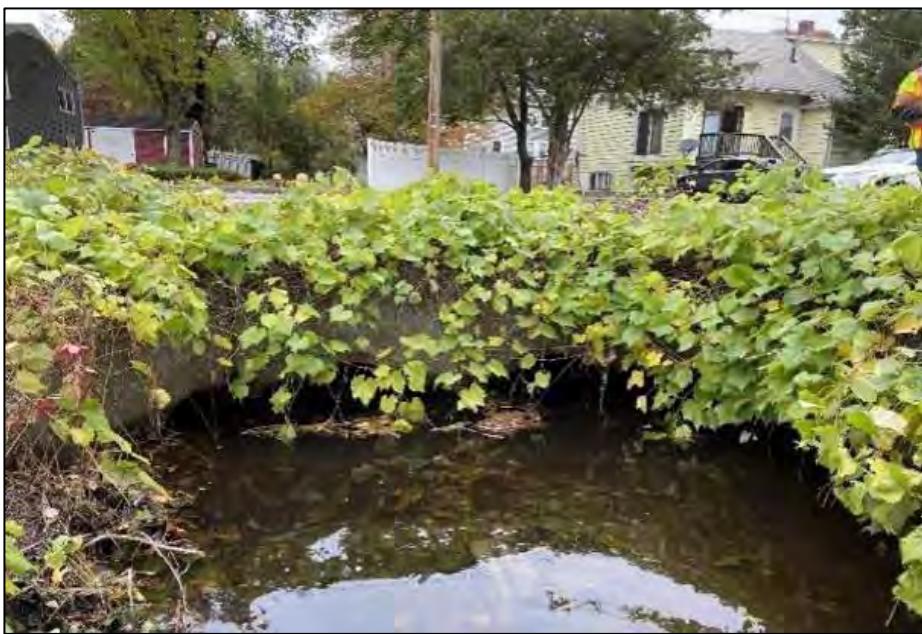
Photo No. 15.: East Street – Crossing Downstream End. Invert is silted.

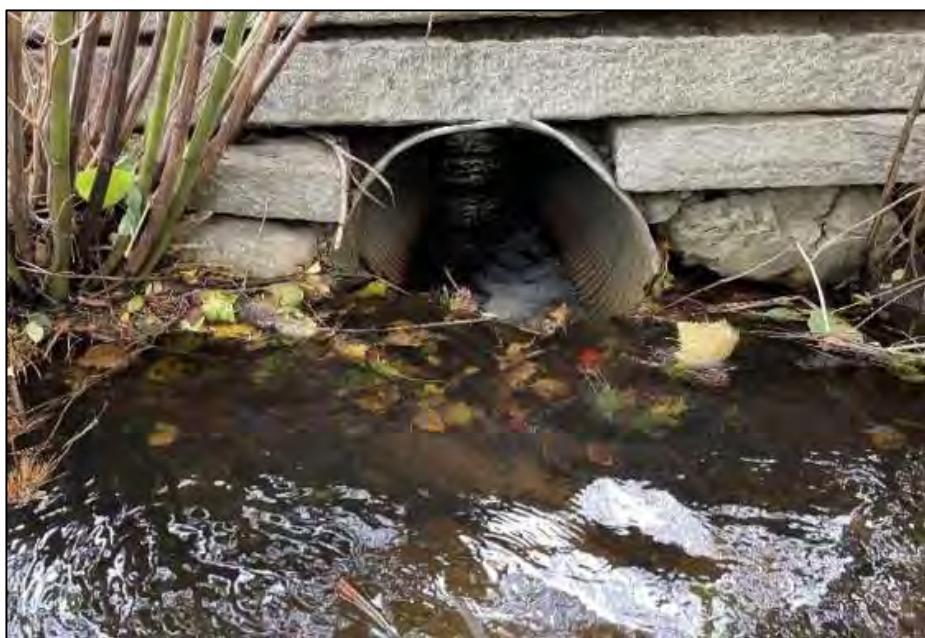
Photo No. 17.: Jehovah's Witness Parking Lot – Upstream Invert. Note debris at inlet creating upstream water levels 1-foot higher than invert.

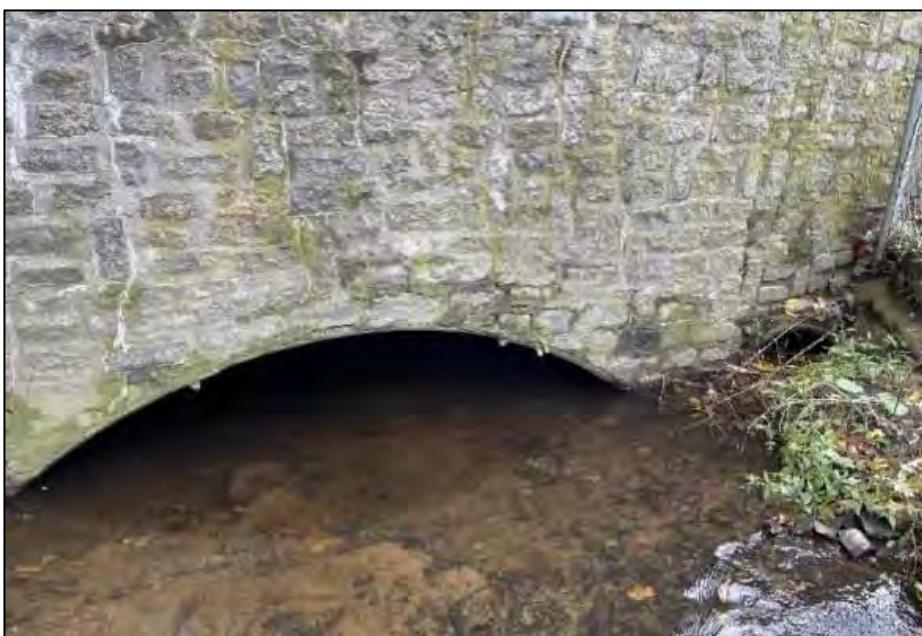
Photo No. 21.: Jackson Street – Downstream Invert. Note the limited height (less than 2 feet) due to apparent sedimentation issues.

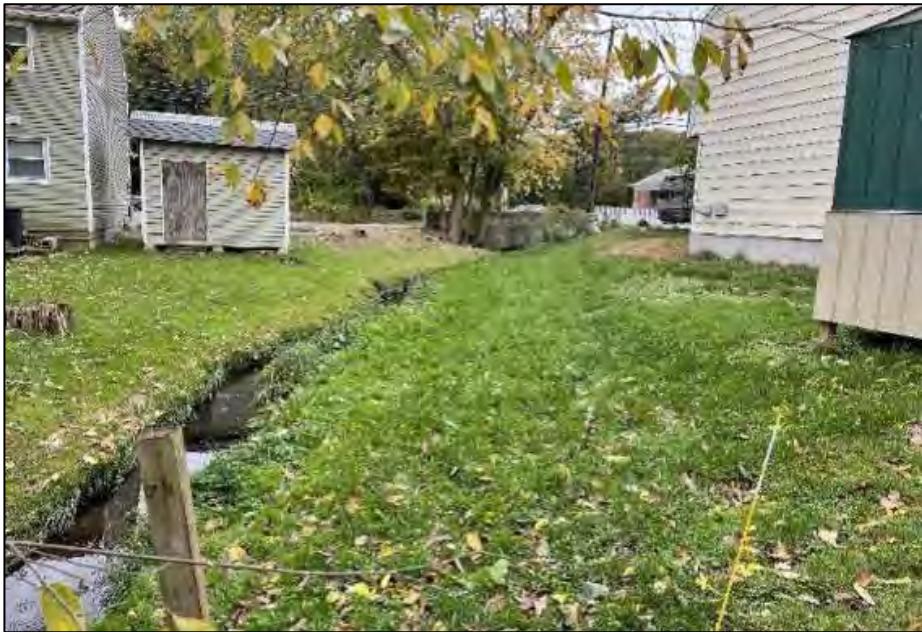
Photo No. 22.: Bicknell Avenue Culvert #1 – Channel from Jackson Street. Note narrow channel with highly erodible banks.

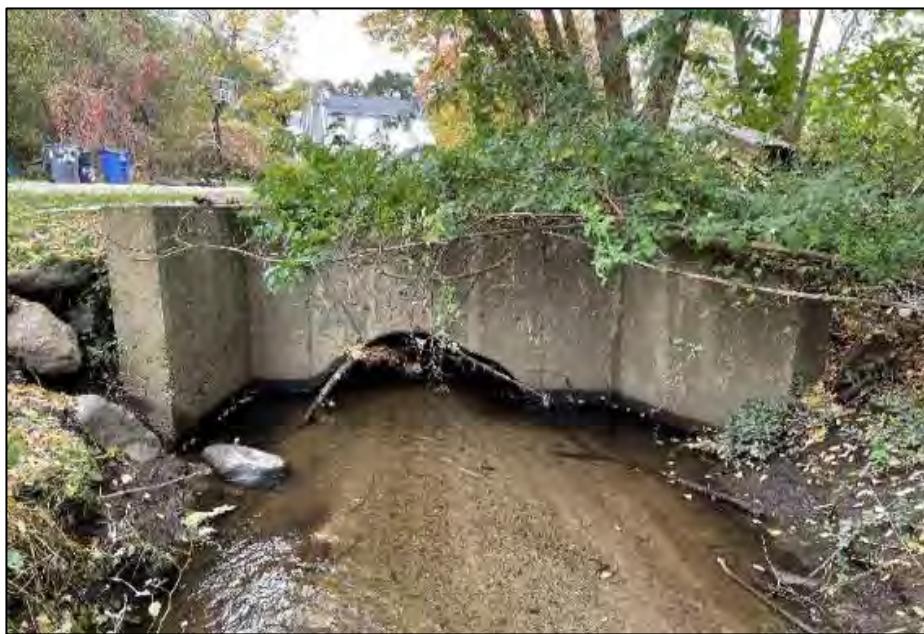
Photo No. 23.: Bicknell Avenue Culvert #1 – Upstream Invert. Note the sediment accumulation at the pipe culvert and at the center of the channel.

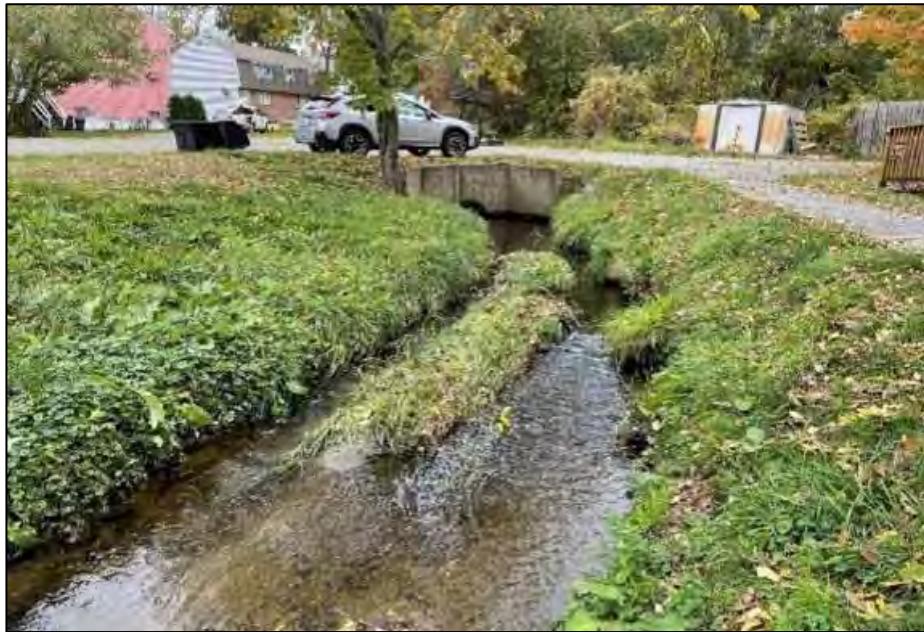
Photo No. 24.: Bicknell Avenue Culvert #1 – Downstream Invert. Note that sediment has accumulated in the middle of the channel and is growing vegetation.

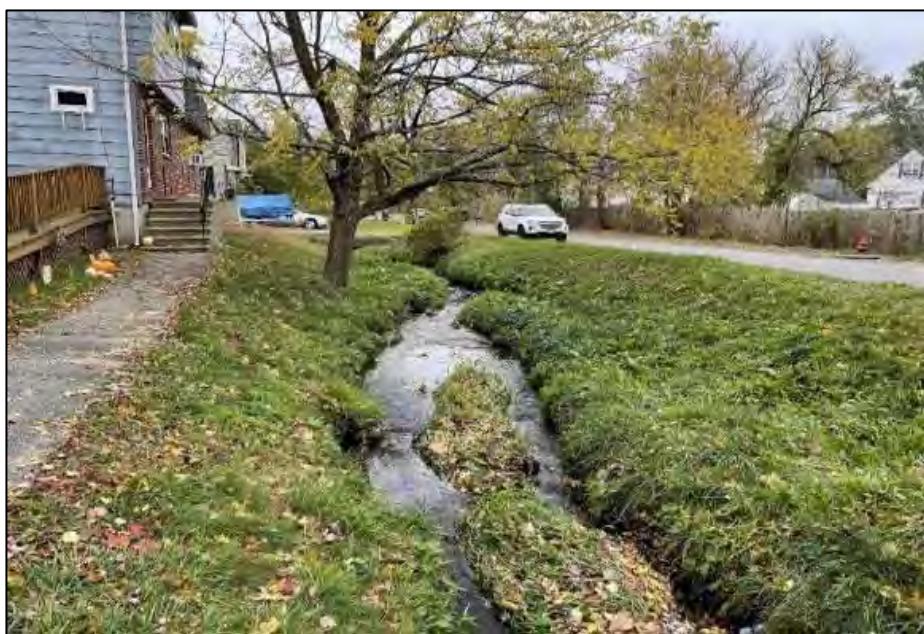
Photo No. 25.: Bicknell Avenue Culvert #1 – Bicknell Avenue Culvert #2 Channel looking downstream. Note the sedimentation and unprotected banks prone to erosion.

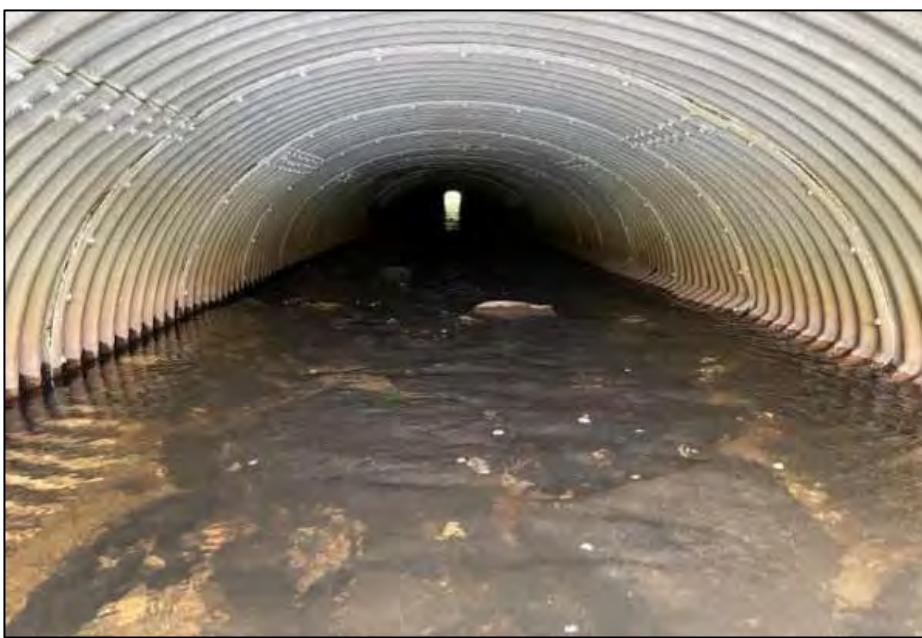
Photo No. 33.: Bicknell Avenue Culvert #5 looking downstream. Note apparent sage in top of pipe at mid-length (estimated at 1 foot).

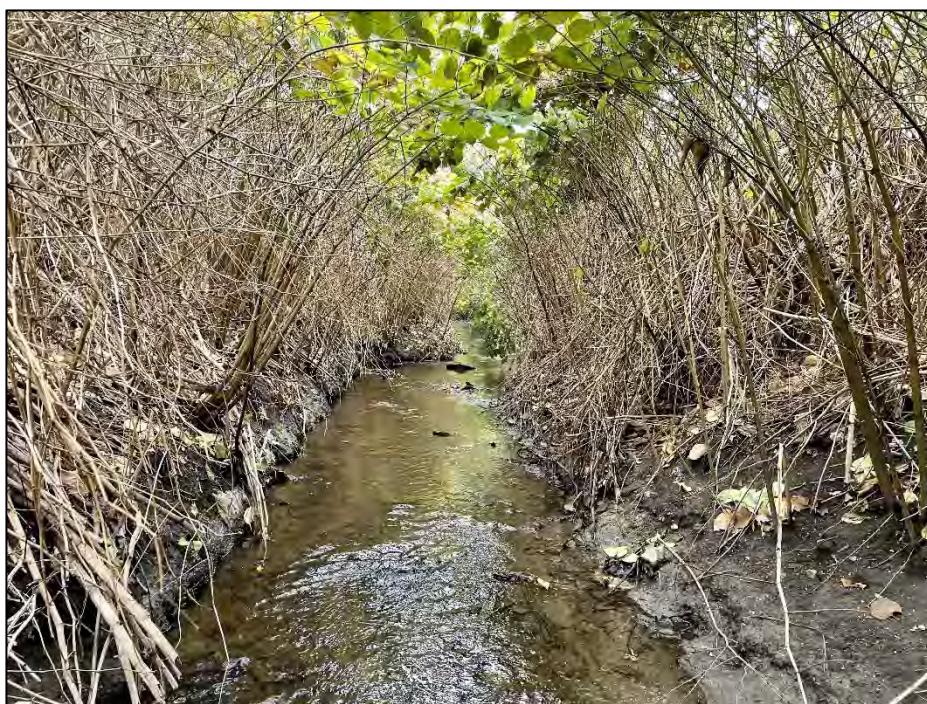
Photo No. 35.: Channel between Curtis Street and inlet of Bloody Brook Culvert. Note overgrowth, sedimentation, and channel banks prone to erosion.

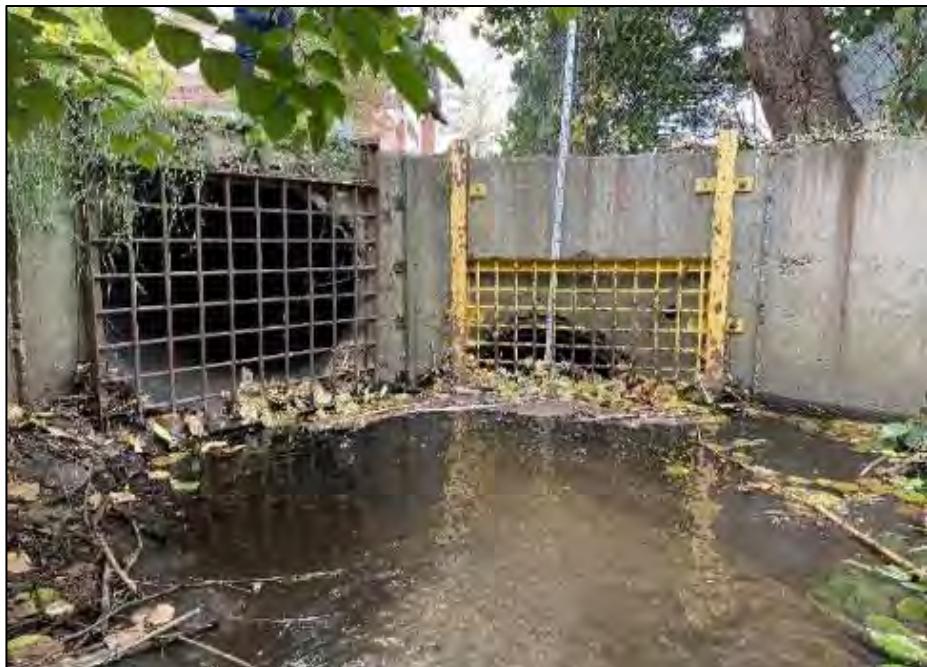
Photo No. 36.: Final crossing behind CVS Parking Lot. Slight debris accumulation on the cage of the outlet.
