Merrimack River Watershed Council
Water Quality Monitoring Program
2020 Year-End Report

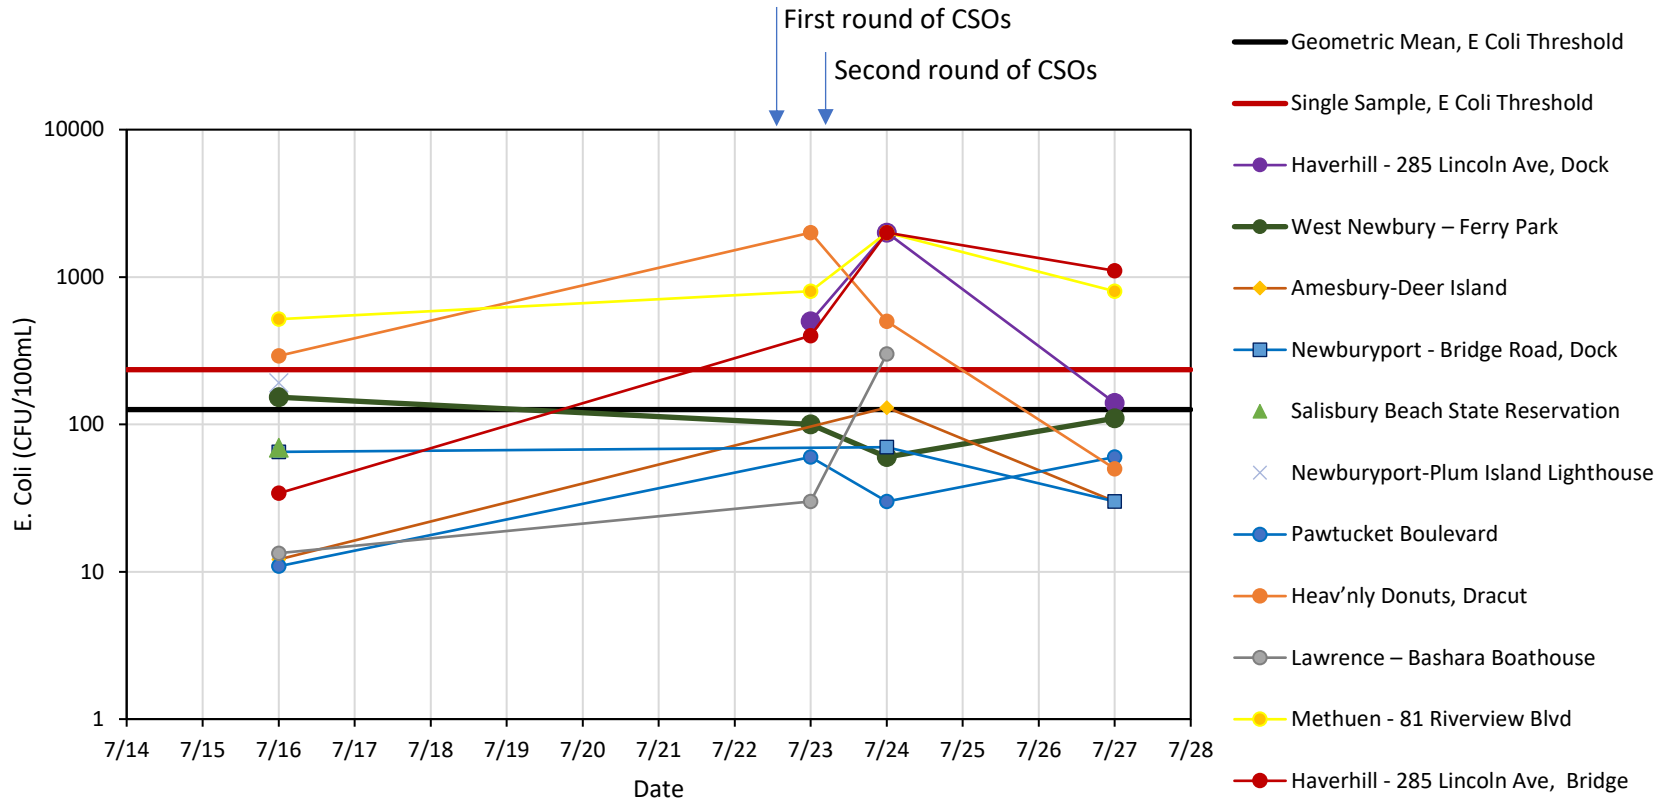
Figure 3: Time series of *E. coli* counts during the first CSO event.

From the CSO data collected, several trends were observed. For CSO 1, high concentrations of bacteria were observed during three days of sampling, though a significant decrease in concentration was observed by 7/27/20, three days after the end of the CSO. During CSO 1, there were multiple releases of untreated sewage from several wastewater treatment plants, which made it difficult to directly track the movement of the untreated sewage down the river.

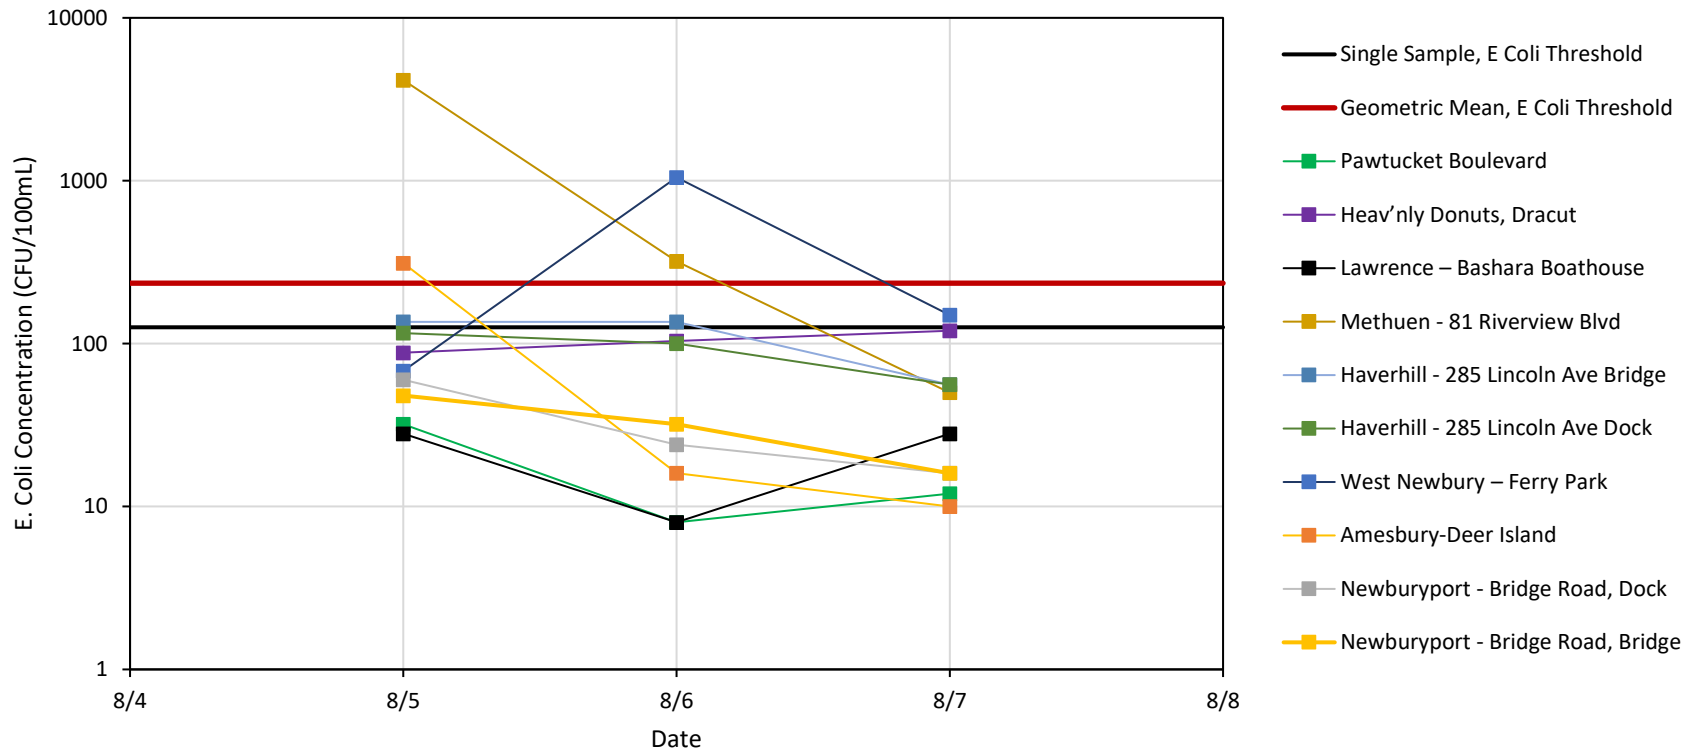
Figure 4: Time series of E. coli counts during the second CSO event.

In comparison, CSO 2 was relatively simple, with only Haverhill releasing untreated sewage. Interestingly, on the first sampling day for this CSO (8/5/20), the highest concentration, 4150 CFU/100mL, was detected at 81 Riverview Blvd, Methuen, which is upstream of the only reported discharging municipality- Haverhill. The following day (8/6/20) an elevated concentration, 1048 CFU/100mL, was observed at Ferry Park in West Newbury, suggesting the bacteria observed in Methuen the previous day and/or the bacteria from the Haverhill plant had moved down the river to West Newbury. By the third sampling day (8/7/20), the bacteria observed in West Newbury had moved through the river to the ocean or had decayed down to levels not significantly higher than the bacteria concentrations found elsewhere in the river.

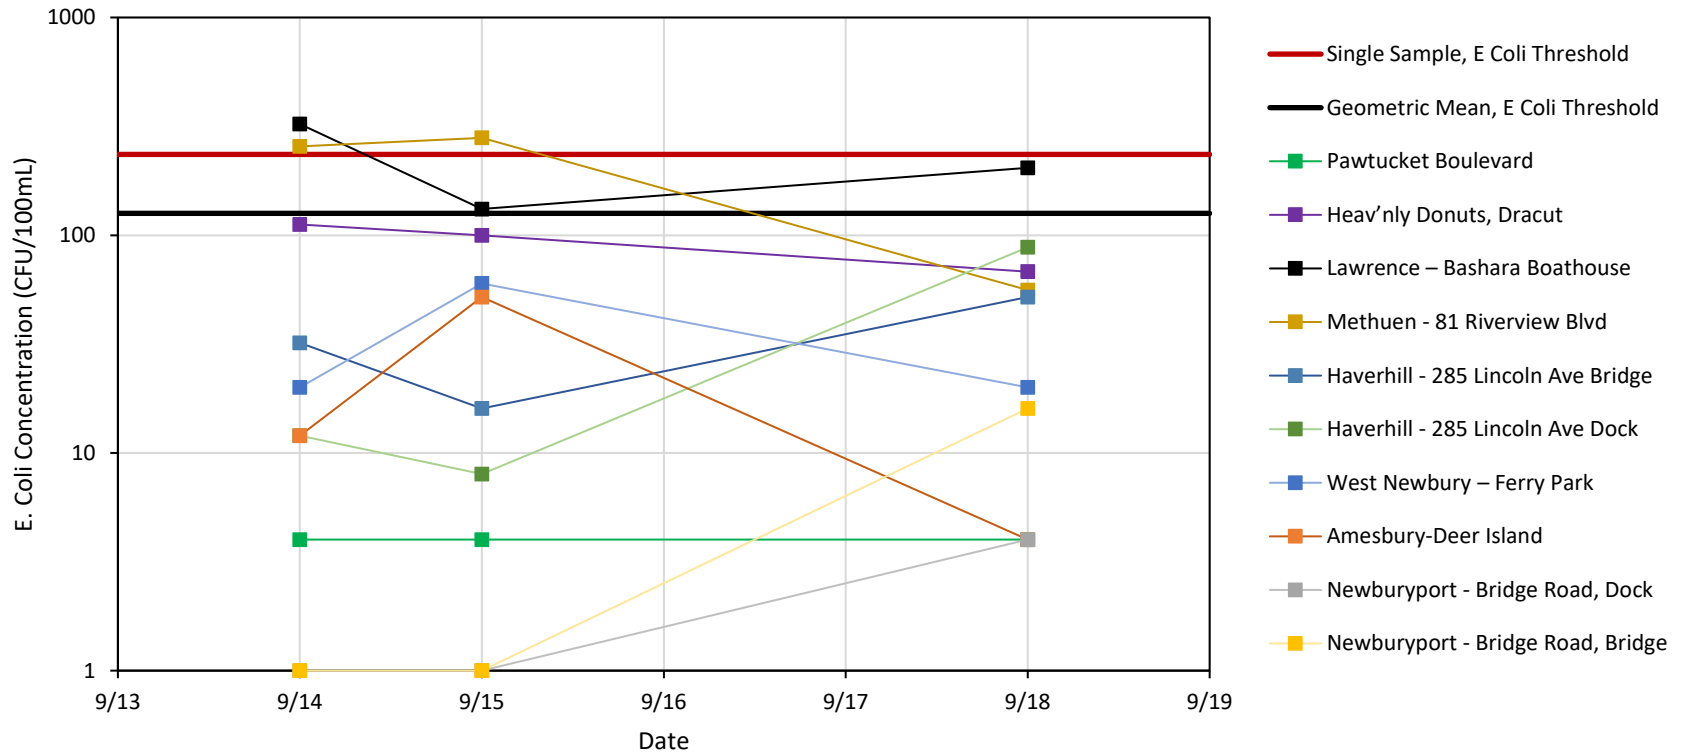
Figure 5: Time series of E. coli counts during the third CSO event.

Due to limitations in laboratory availability for testing (all are closed on weekends), following CSO 3, the team had to wait until the fourth and fifth day following the CSO to collect samples. The team was expecting to see elevated bacteria levels towards the mouth of the river, due to the sewage from the CSO having travelled downstream over time. Surprisingly, the locations close to the mouth of the river (Newburyport, Salisbury, and Amesbury) had low levels of bacteria, suggesting the bacteria from the CSO had decayed or moved out into the ocean. Due to the extremely low flow in the river at the time, the bacteria concentrations decaying away is considered more likely. Interestingly, concentrations exceeding the Massachusetts Surface Water Quality Standards [5] for *E. coli* (235 CFU/100mL) were found in Methuen on both days and in Lawrence on the first sampling day (9/14/2020). While these elevated levels may have been the result of residual bacteria from CSO 3, it is more likely there is a non-CSO source for these unsafe levels of bacteria.

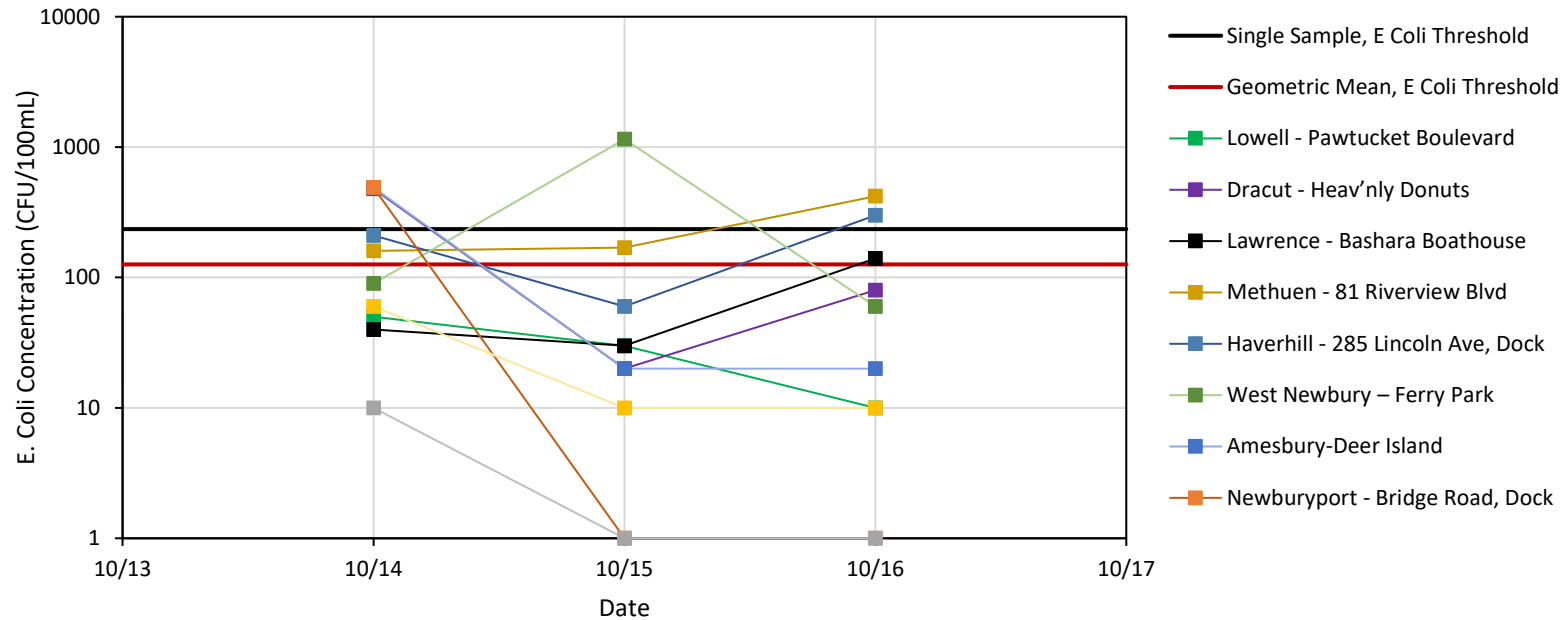
Figure 6: Time series of *E. coli* counts during the fourth CSO event.

Similar to CSO 2, during CSO 4 only Haverhill released untreated sewage. The CSO occurred on 10/13/2020 and samples were collected the following three days. On the first day of sampling (10/14/2020) high concentrations were observed in Dracut, Amesbury, and Newburyport with 480 to 490 CFU/100mL. These high levels were attributed to factors other than the CSO, as Dracut is significantly upstream from the CSO and Amesbury and Newburyport are far enough downstream that the bacteria from the CSO had likely not reached these areas yet. On the second day (10/15/2020) a spike in *E. coli* concentration was observed at Ferry Park in West Newbury. Since there was no additional rain or CSO events, this spike was attributed to the bacteria from Haverhill arriving in West Newbury. By the third sampling day (9/16/2020), the bacteria from the Haverhill CSO was not observed. There were slightly elevated levels of bacteria in Methuen (420 CFU/100 mL) and Haverhill (300 CFU/100mL). These levels were attributed to the rain (0.43 in) that occurred on that day which may have introduced bacteria from other non CSO sources into the river.

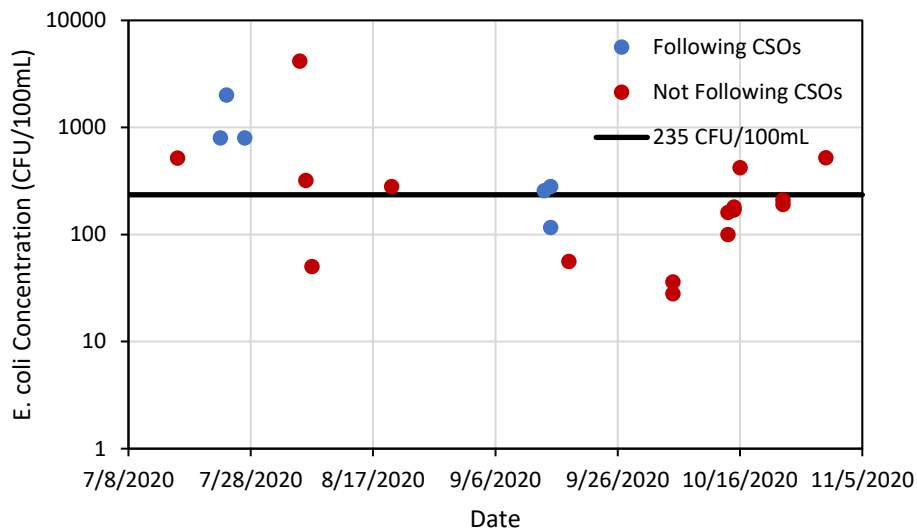
Figure 7: Plot of *E. coli* concentration versus date, from days following and not following CSO events. Note the value of 200 CFU/100mL on 7/24/2020 was reported as >2000 CFU/100mL by the laboratory and the actual value may be significantly higher.

From the data collected by the sampling program, MRWC noticed high levels of bacteria at one sampling location, 81 Riverview Blvd, Methuen. Samples taken along the shore at this site had a significant number of samples above the limit from Massachusetts Surface Water Quality Standards of 235 CFU/100mL for bathing beaches and non-bathing beaches. Over four months of sampling, 22 samples were collected at this site and 11 had bacteria levels above the limit of 235 CFU/100mL. This included 5 of 6 samples collected following upstream CSOs, as well as 6 out of 16 samples collected not following upstream CSOs. This represented a significantly higher rate of exceedance at this site than the other sites being sampled.

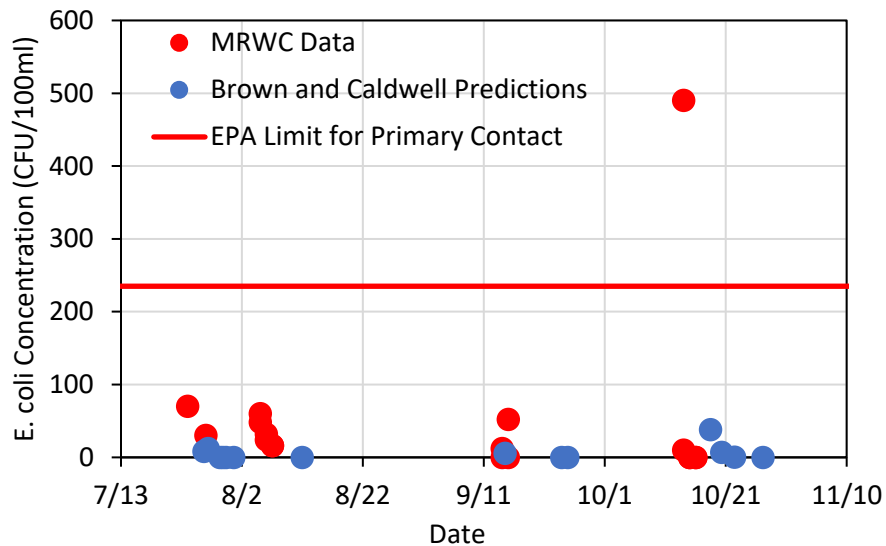
Figure 9: Plot of E. coli concentration measured by MRWC and the concentrations predicted by Brown and Caldwell’s predictive models.

Brown and Caldwell has worked with the City of Newburyport to develop a model that predicts the movement of bacteria concentration down the Merrimack River following CSO events. Using data on the amount of untreated sewage released and the flow rate of the river, the model predicts the *E. coli* concentrations in Newburyport. To validate this model, MRWC has shared our sampling data from the CSO events that occurred in summer/fall 2020. Brown and Caldwell’s model predicted low bacteria levels arriving in Newburyport several days after the CSOs. MRWC’s results were in general agreement with Brown and Caldwell’s model, finding the *E. coli* concentrations in Newburyport were not significantly higher following CSO event than the *E. coli*

levels on a typical dry sampling day. The model and the field data predicted safe levels following the three CSO events. The only exception was a sample collected on 10/14/2020, but the team believes these high levels were from stormwater runoff. The sample on 10/14/2020 was collected 18 hours after a CSO in Haverhill started. Brown and Caldwell’s model predicted the bacteria from this CSO would take 3 and a half days to reach Newburyport, given the flow rate in the river at that time. Therefore, the team is confident the issue is not the result of a mistake in calculating the travel time of the bacteria and instead the bacteria concentrations are the result of another bacteria source.

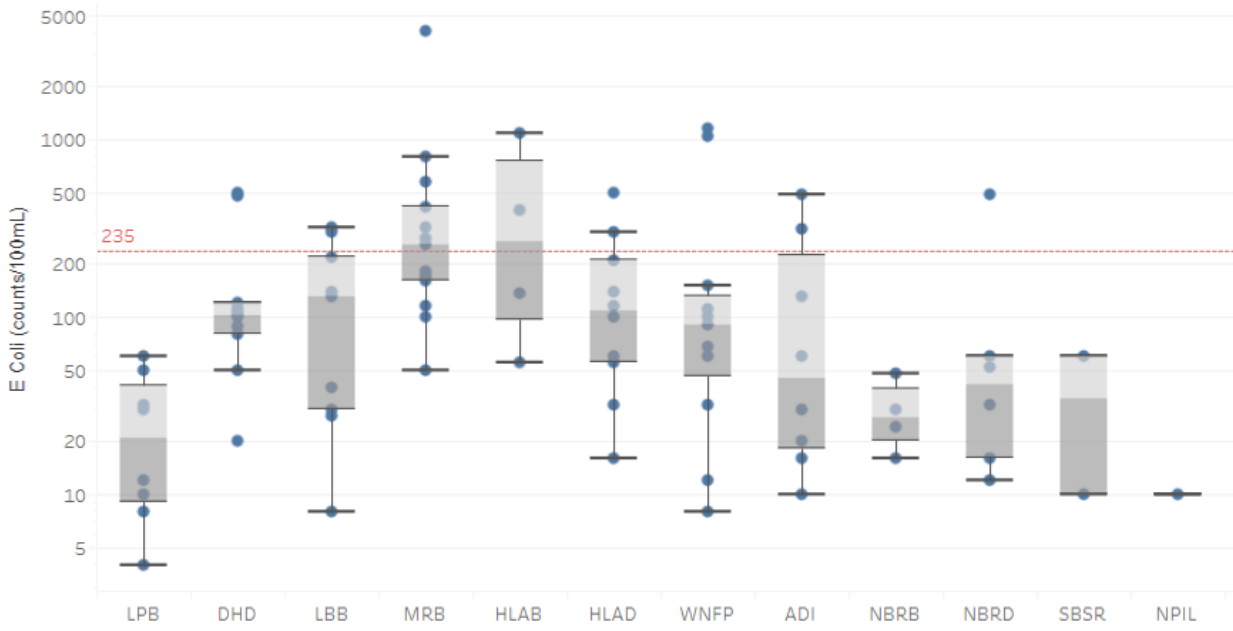
Figure 12: Box and whisker plot of E. coli concentration on the 4 CSO sampling days.

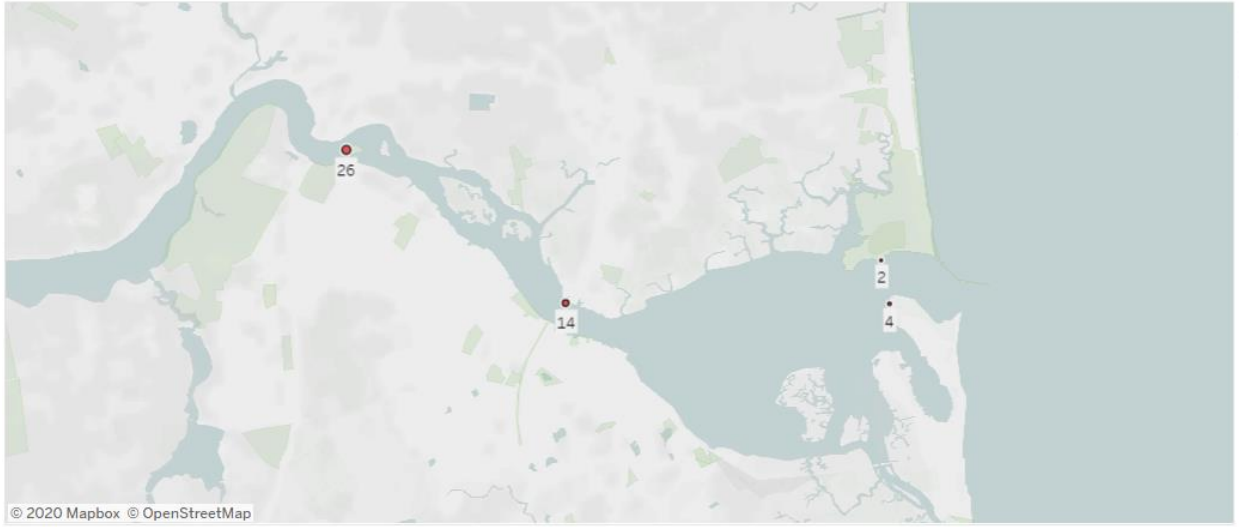
Figure 13: Map displaying the enterococcus concentrations at each site following 4 CSO events.

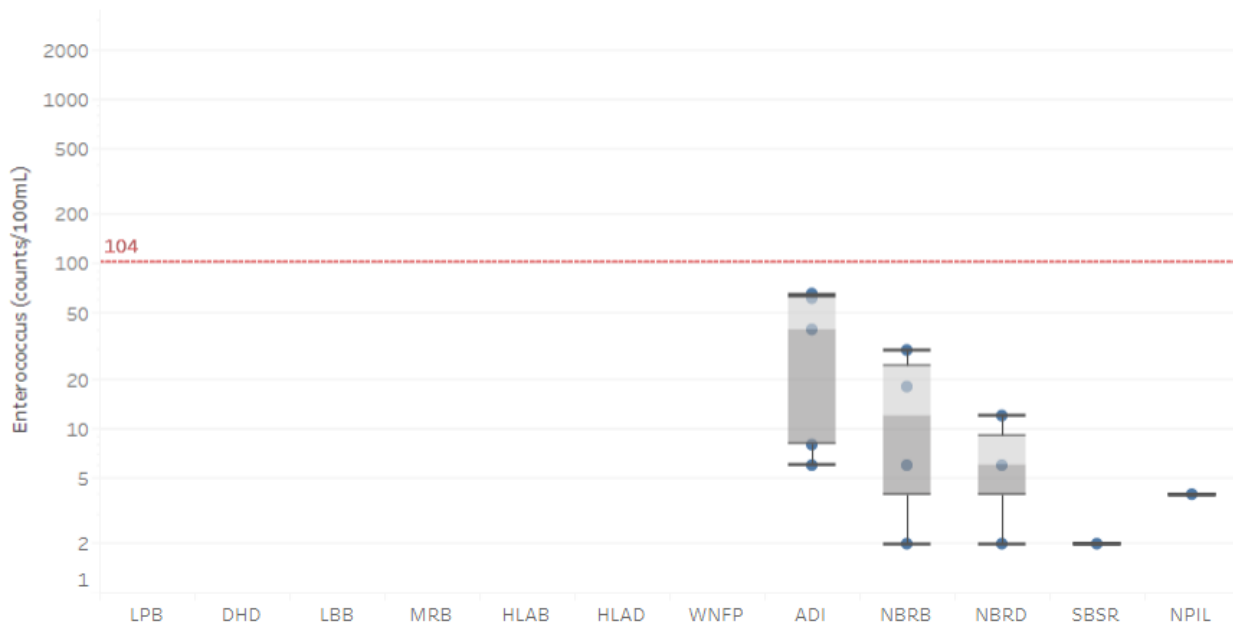
Figure 19: Box and whisker plot of *enterococcus* concentration on the 4 CSO sampling days.
