**MERRIMACK RIVER
WATERSHED COUNCIL**

2021 WATER QUALITY REPORT

March 2022

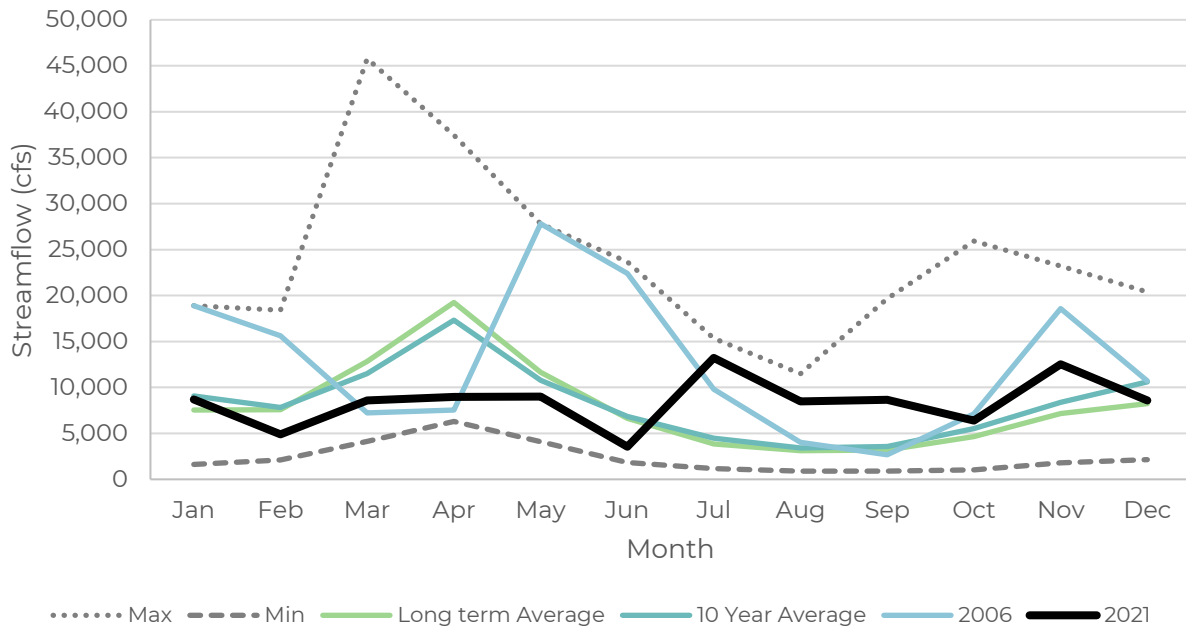
Figure 4. Average monthly streamflow at the USGS Gauge in Lowell, for different time periods.

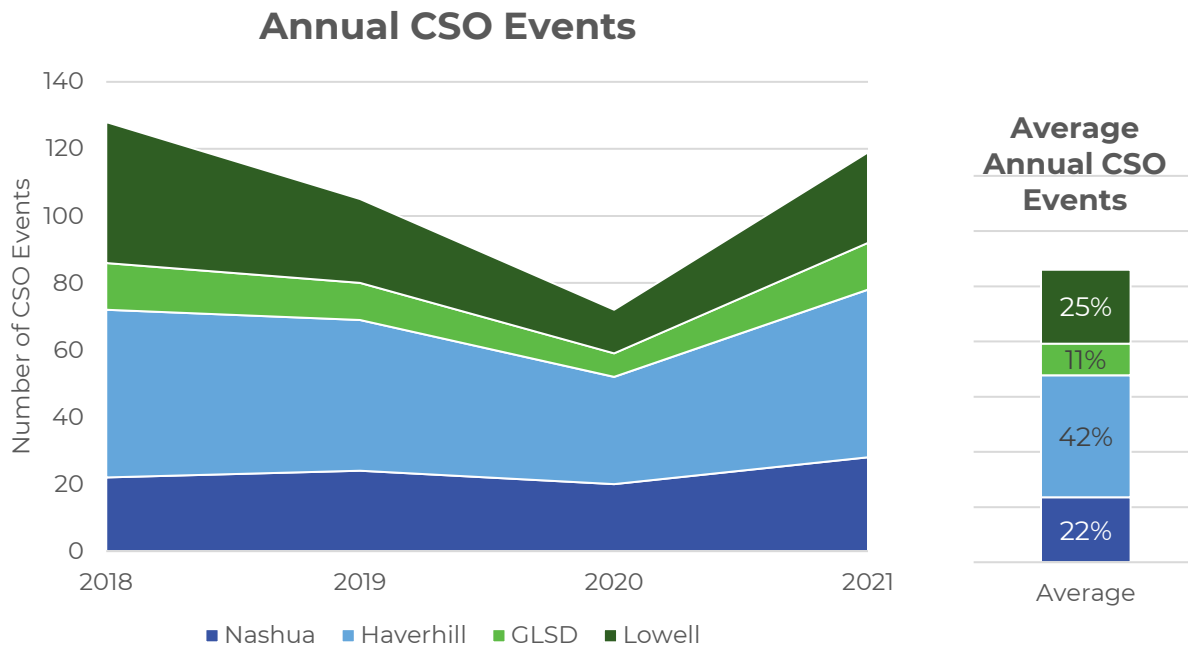
Figure 6. Average annual number of CSO events from four combined systems on the Merrimack. For 2021, the individual CSO event data for Haverhill were not available at the time this report was prepared. Manchester did not report on individual CSO events in 2021, they only released total annual volumes once per year, and therefore were not included.

In terms of the number of CSO events in each year, Haverhill is the largest contributor historically, contributing 42% of the total CSO events each year (44 events on average, Figure 6). Haverhill typically has frequent but small volume events compared to Lowell or GLSD, which have less frequent but larger events. In 2021, we estimated that Haverhill contributed the same number of CSO events as in 2018 (the year with the closest annual volume to 2021), as individual event data were not available at the time this report was prepared (Figure 6). Manchester is not included in the CSO event analysis because they did not report individual events in 2021. At the time this report was prepared, Manchester only reported total annual volumes once per year. While 2021 saw the greatest volume in CSOs, 2018 still holds the maximum for number of CSO events, assuming Haverhill did not produce more events in 2021 than in 2018 (Figure 6).

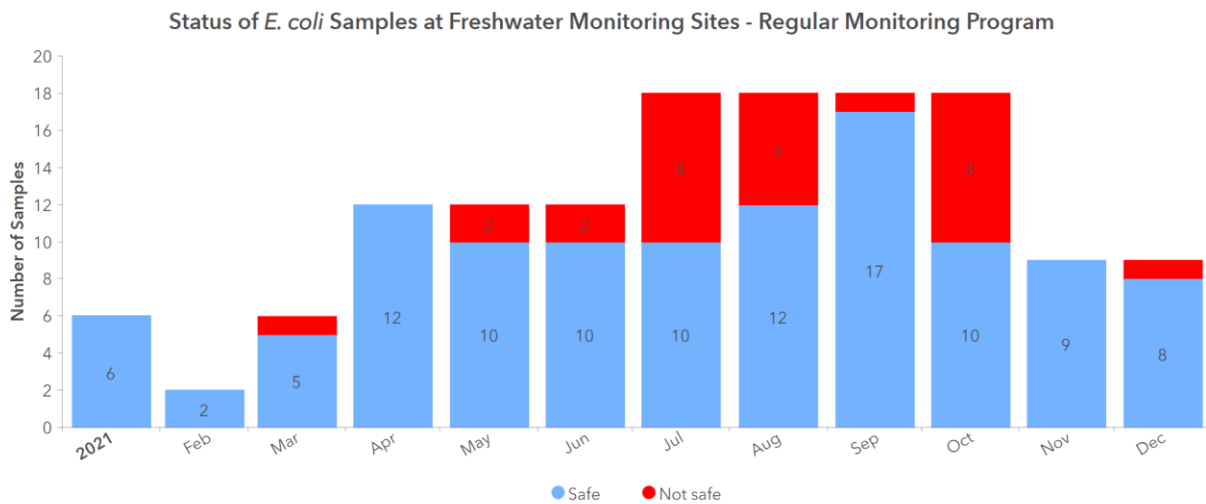
The *E. coli* results for the four most downstream sites were not included as *E. coli* is a poor indicator species in brackish water

Only the brackish sites (the four most downstream sites) were monitored all year. The freshwater sites were monitored beginning in July 2021 and have not been included in this analysis

Looking at these results by month, most samples were within the safe limit during spring, fall and winter (Figure 15). However, during the summer months of July through October, there were more unsafe samples than other months. This is important to note since these are the months where many recreational activities take place, increasing the exposure risk to humans. This is the period of time with frequent large rain events (such as summer thunderstorms) and CSO events. As such, these higher numbers could be due to the fact that some of our regularly scheduled monitoring days occurred during wet weather and CSO events.

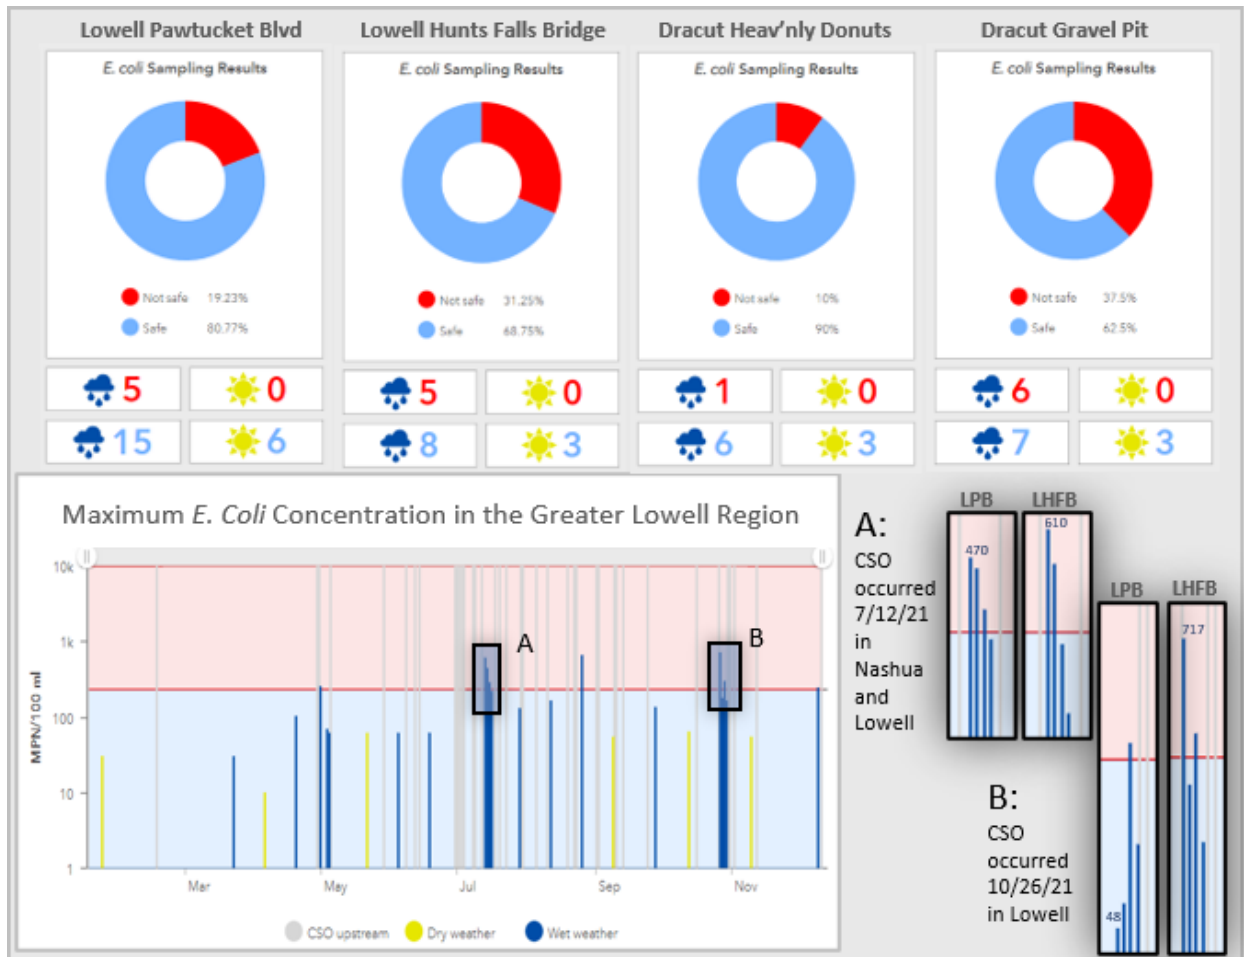
Figure 20. Results of *E. coli* sampling at the sites within the Greater Lowell region.

In summary, just because there is rain or a CSO upstream, it does not mean the river is unsafe to use in this location. After significant rain events, however, bacteria levels in this region may stay unsafe for up to three days.

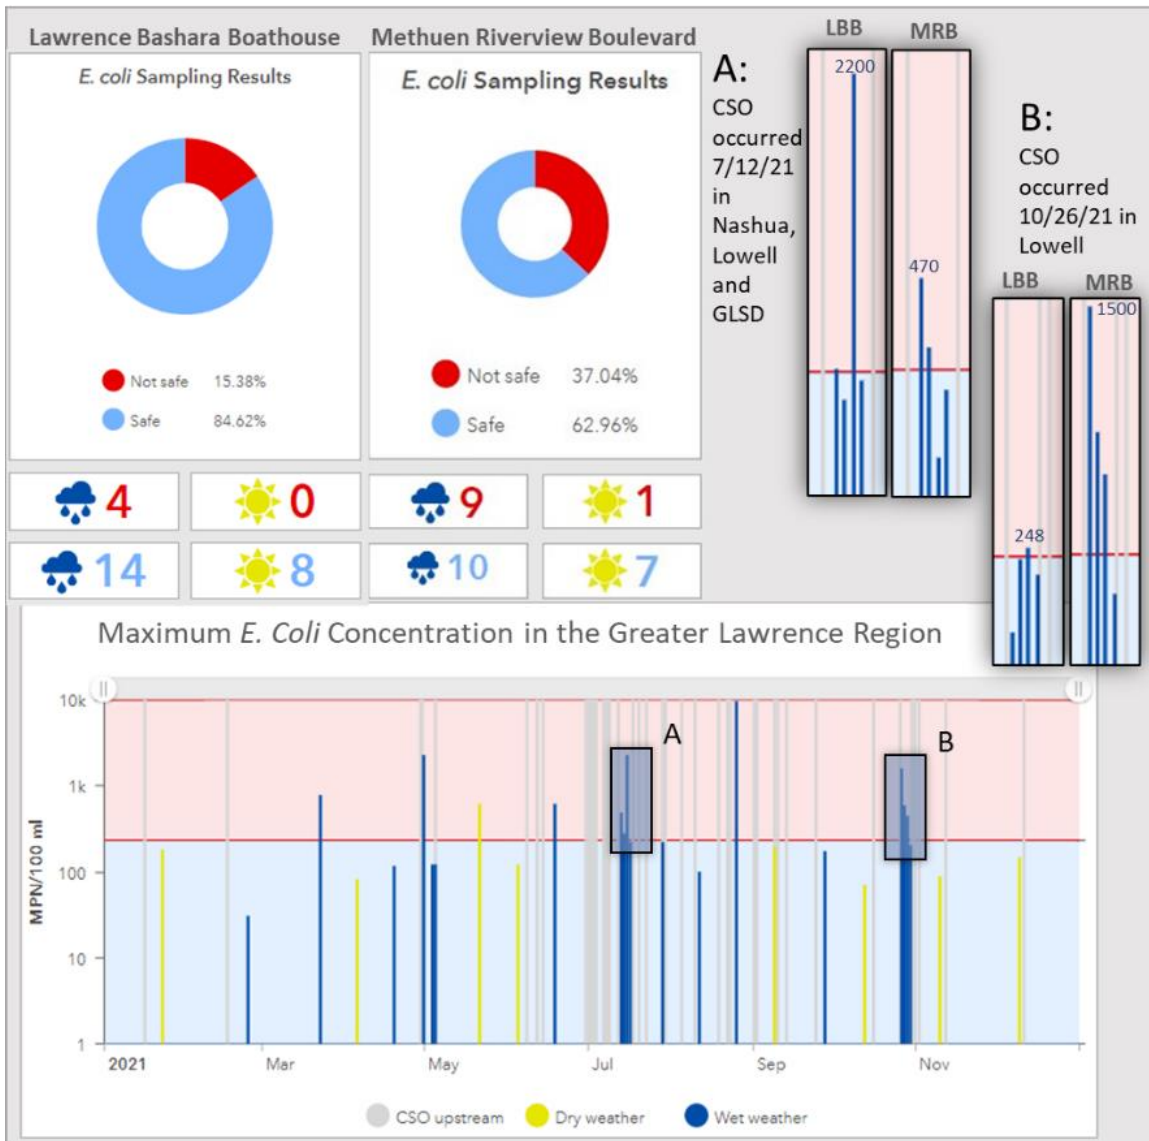
Figure 21. Results of *E. coli* sampling at the sites within the Greater Lawrence region.

In summary, it is likely that a combination of sources of bacteria are contributing to bacteria contamination at the Methuen site, leading to more frequent unsafe conditions here than most other sites that we monitor. The Lawrence site is safe a large percentage of the time, except following CSOs that occur upstream.
