**MERRIMACK RIVER  
WATERSHED COUNCIL**

## 2022 WATER QUALITY REPORT

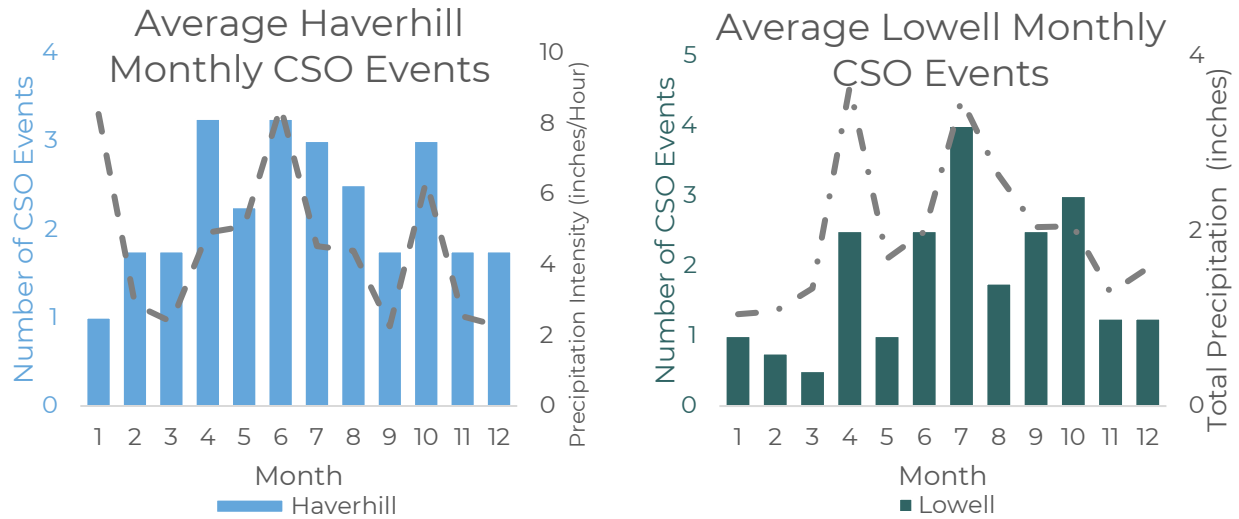
Figure 3. Average monthly (numeric calendar year order) CSO events and rainfall intensity at Haverhill (left, averaged over 2019-2022) and average monthly CSO events and total rainfall at Lowell (right, averaged over 2019-2022).

Heavy rainfall causes CSO events in the Merrimack River. Rainfall intensity is the amount of rain that falls in a set time period, usually measured in inches per hour. Combined sewer systems vary in how they respond to rainfall. In Haverhill, for example, rainfall intensity is a good predictor of whether a CSO event will occur or not (Figure 3, left). In Lowell, for example, total rainfall is a better predictor (Figure 3, right). Once a larger dataset is available, further analysis of these patterns could lead to predictions of whether a CSO will occur and where it will occur given rain conditions.

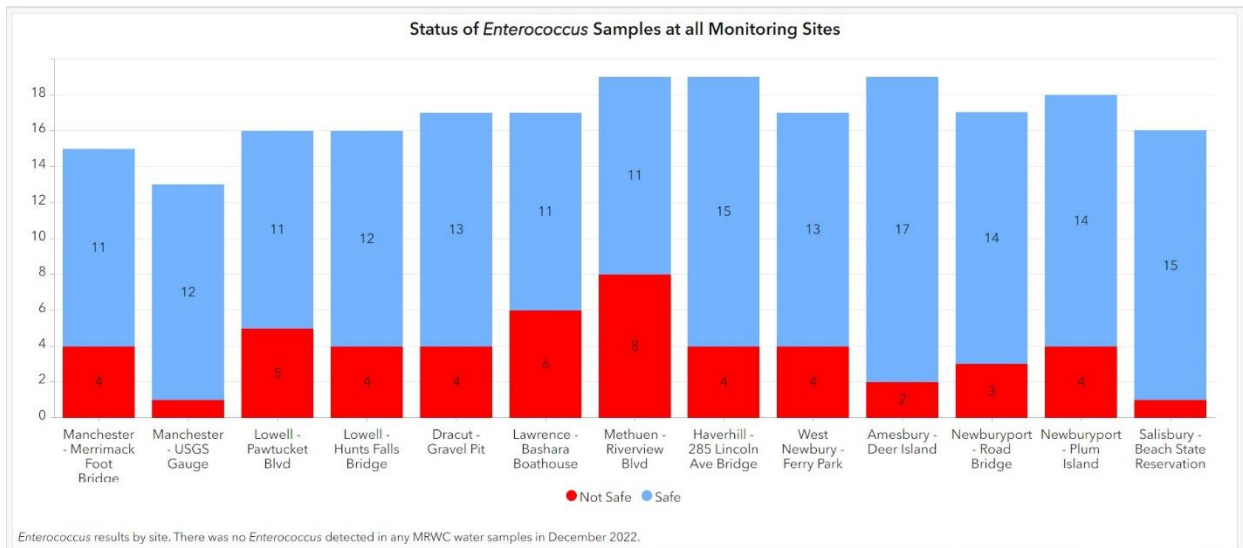
Figure 14. Number of safe and not safe samples by monitoring site for *E. coli* at freshwater monitoring sites (a) and *Enterococcus* monitoring sites (b) in 2022.

Looking at these results by monitoring site, the data show that most samples are considered safe throughout the Merrimack but there are unsafe samples at each site (Figure ). It is worth noting that Manchester USGS Gauge and Salisbury Beach State Reservation each had only one unsafe sample during regular monitoring activities, while Methuen had the highest number of unsafe samples. This is interesting due to the high conductivity and salinity also found at this site. Further site-specific analyses on potential reasons are provided in the regional profiles section.

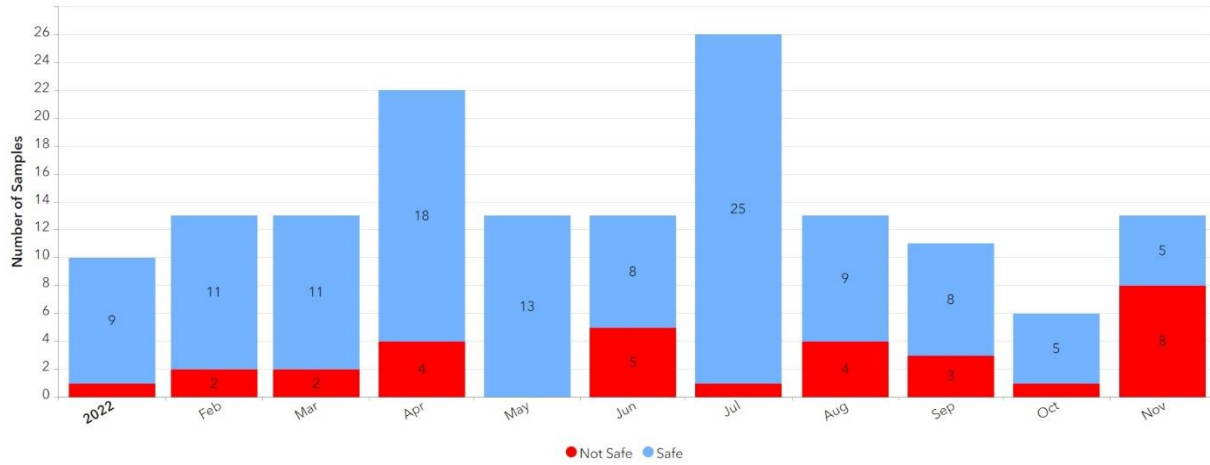
The *E. coli* results for the four most downstream sites were not included as *E. coli* is a poor indicator species in brackish water

Status of *Enterococcus* Samples at All Monitoring Sites - Regular Monitoring Program

*Enterococcus* results for all sites. There was no *Enterococcus* detected in any MRWC water samples in December 2022.

Looking at these results by month, most samples were within the safe limit during spring and early summer (Figure ). However, during the June, August, and November there were more unsafe samples than other months. It is important to note that in May through early August in 2022, Massachusetts experienced a drought. The low bacteria concentrations that occurred in June and July during a time of recreation are most likely due to lack of rain events.

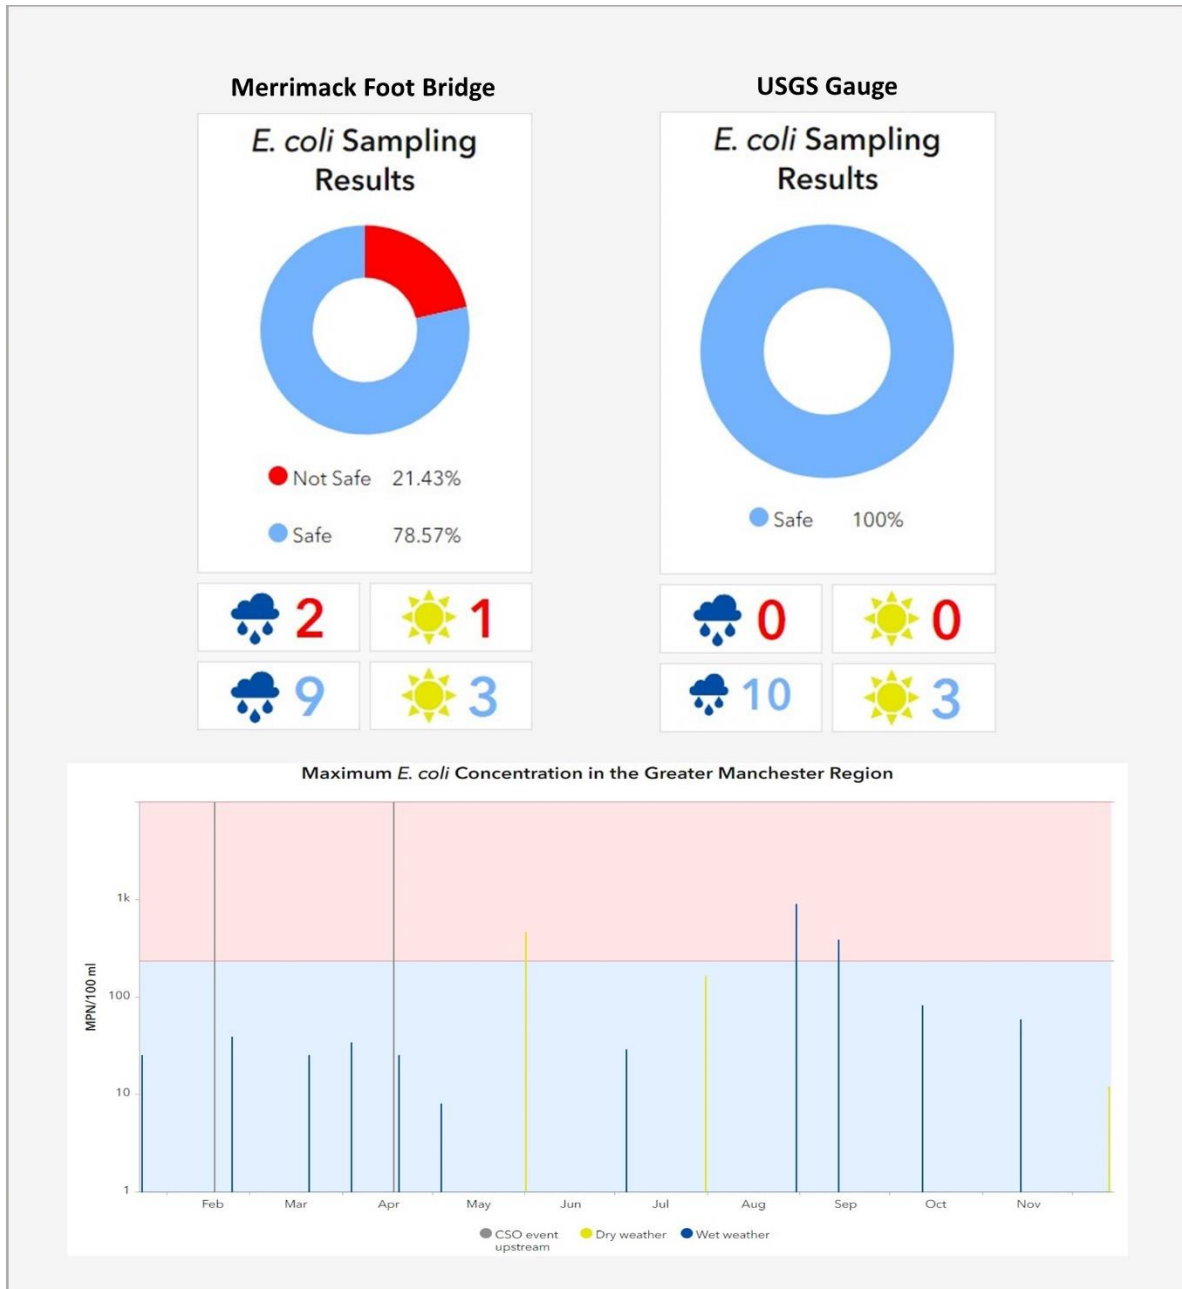
Figure 16. Results of *E. coli* sampling at the sites within the Greater Manchester region.

The circle graphs at the top indicate safe (blue) and unsafe (red) samples at each site. The number below the circle charts show the percentage and count of samples that are safe and unsafe, and whether they occurred during wet or dry conditions. The time series shows the maximum concentration samples collected on each sampling day in this region.

Overall, 21% of the samples collected in greater Manchester have *E. coli* levels that were above the safe limit (Figure 6) and 31% of the samples collected have *Enterococcus* levels that were above the safe limit (Figure 17). The more downstream site at Manchester – USGS Gauge (MUG) had zero unsafe *E. coli* samples while the more upstream site of Merrimack Foot Bridge (MMFB) had unsafe concentrations. The site at the USGS gauge also had a much lower concentration of *Enterococcus* than the upstream site at the bridge.

In summary, the majority of samples in this area are safe. However, the data suggests bacteria may persist in the system for at least 72 hours after a rainstorm, which is important to note for recreational purposes.

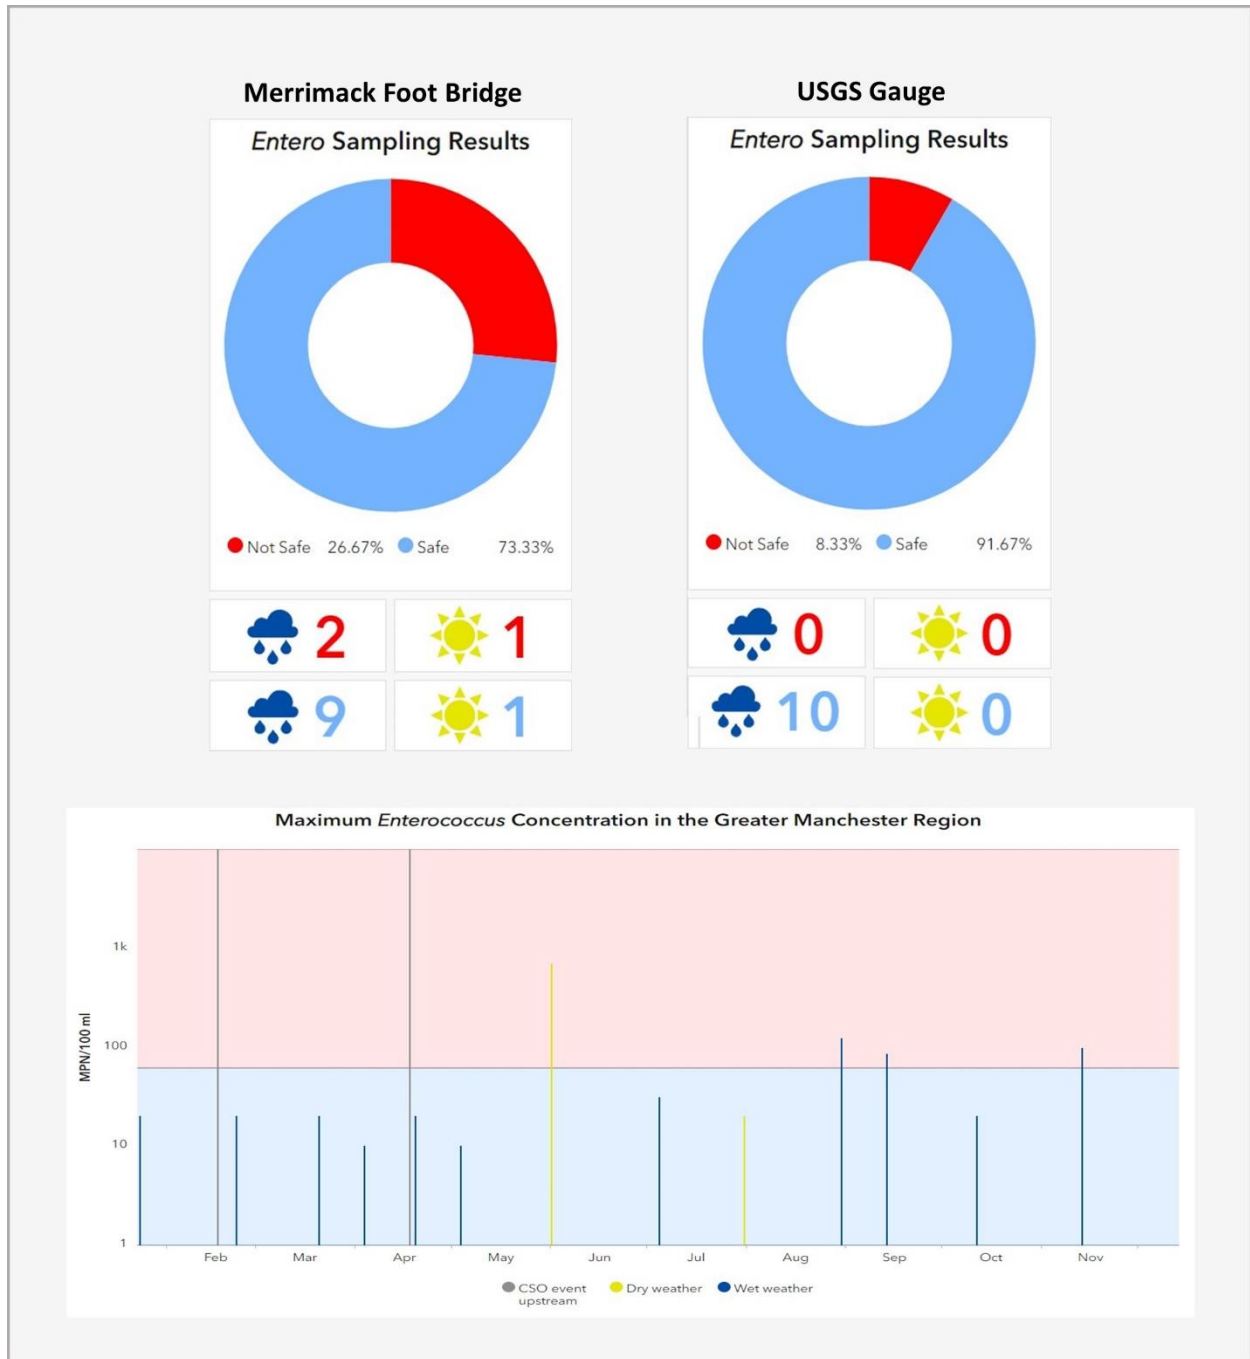
Figure 17. Results of Enterococcus sampling at the sites within the Greater Manchester region.

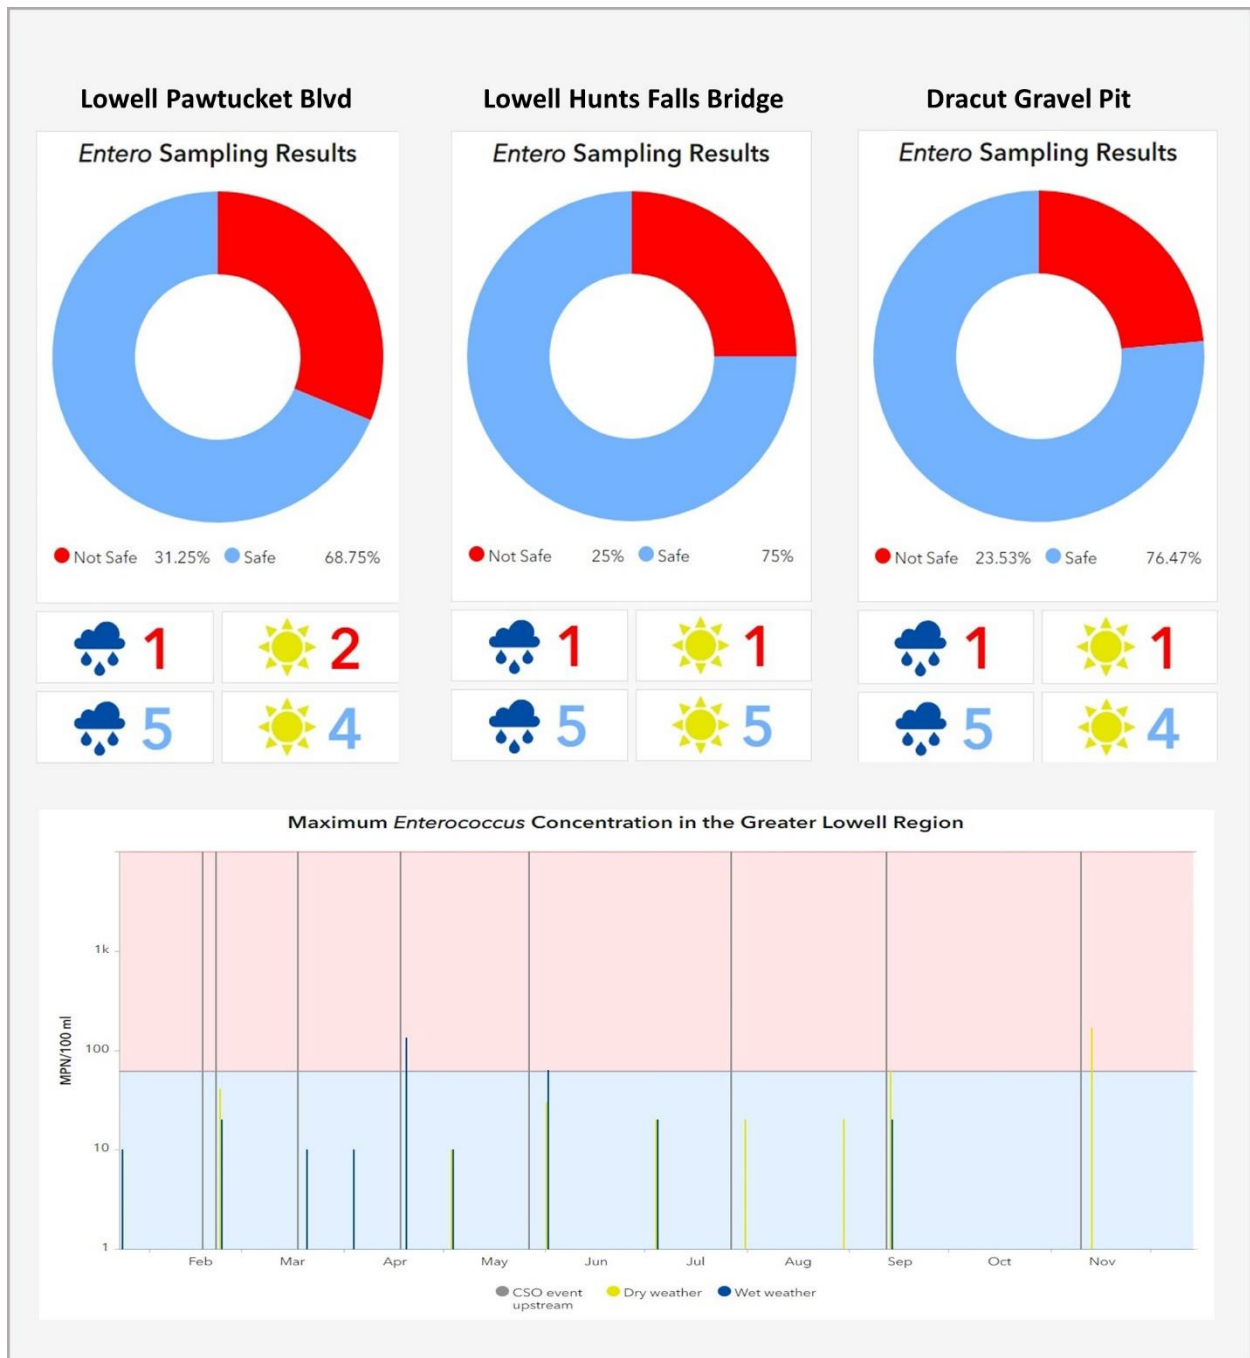
Figure 19. Results of Enterococcus sampling at the sites within the Greater Lowell region.

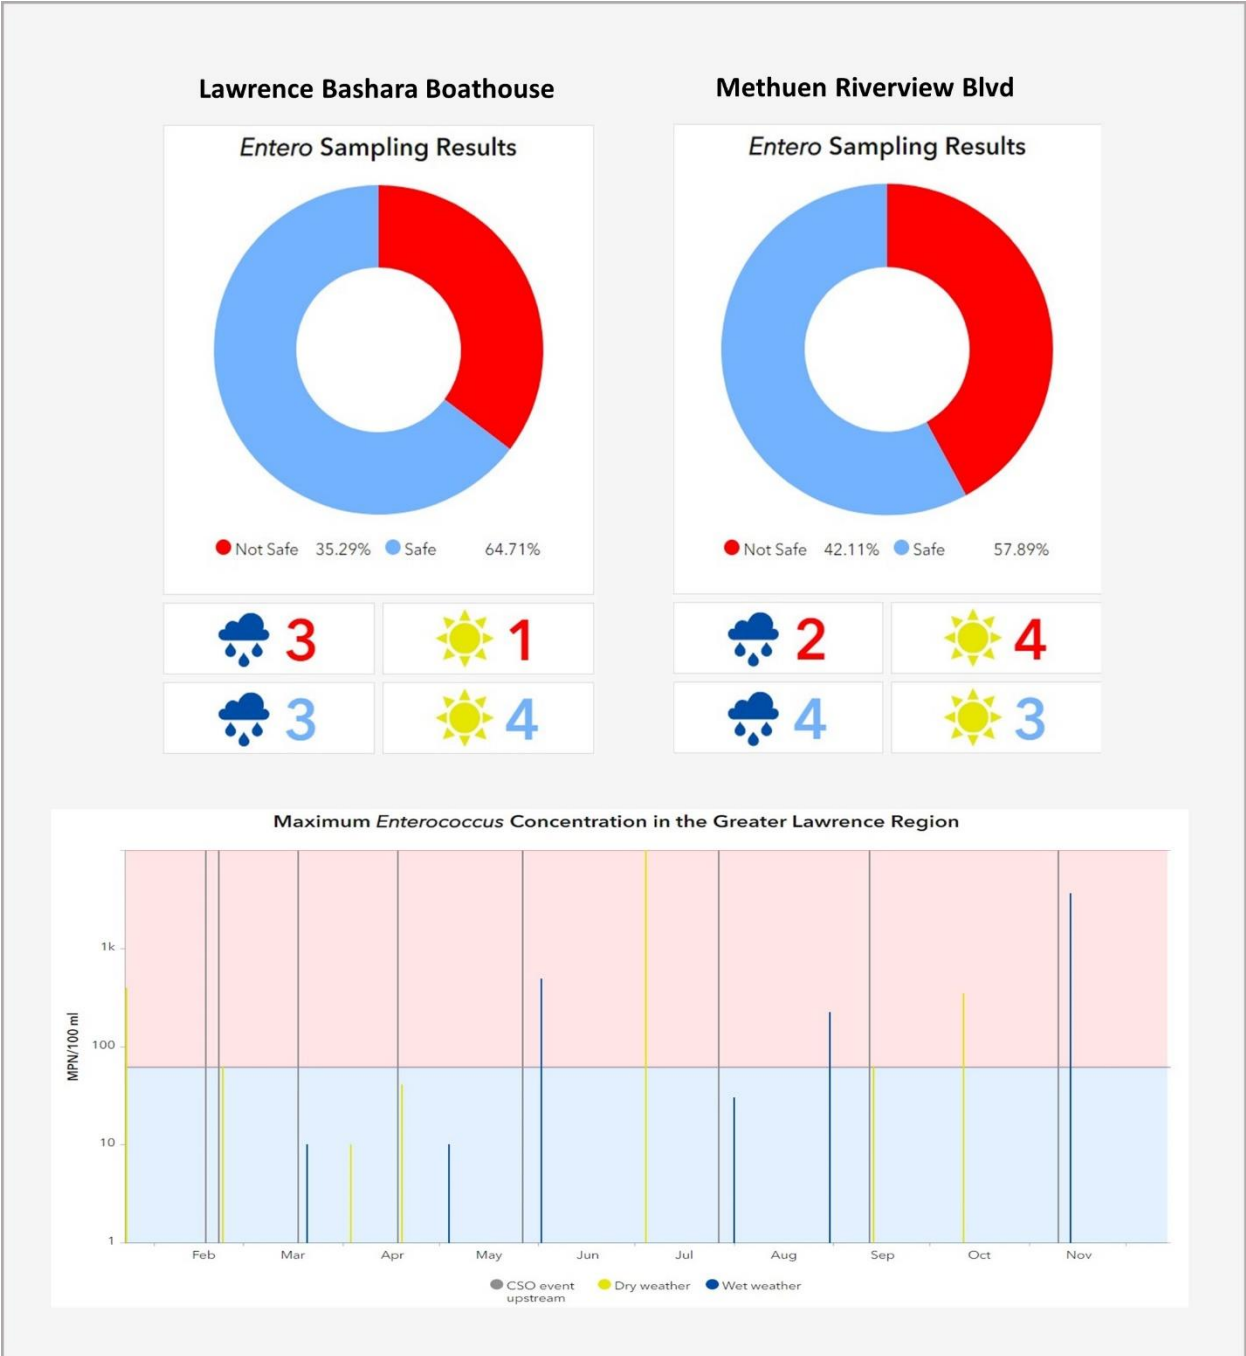
Figure 21. Results of Enterococcus sampling at the sites within the Greater Lawrence region. The circle graphs at the top indicate safe (blue) and unsafe (red) samples at each site. The number below the circle charts show the percentage and count of samples that are safe and unsafe, and whether they occurred during wet or dry conditions. The time series shows the maximum concentration of samples collected on each sampling day in this region, relative to upstream CSO events shown by grey lines (since daily CSO event data is not available for Manchester, it is therefore assumed that all CSO events occurring upstream of Lowell are from Nashua, NH).

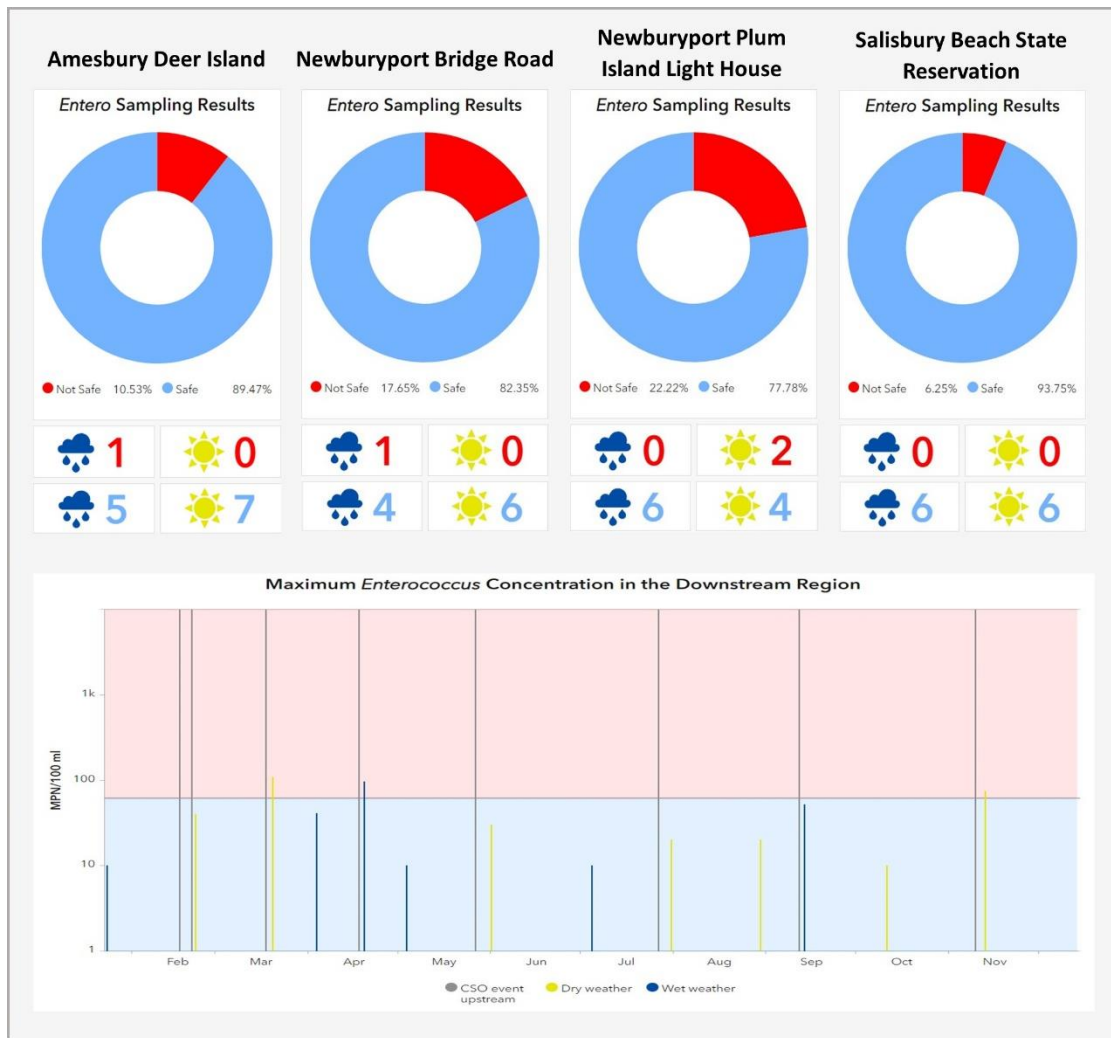
Figure 24. Results of Enterococcus sampling at the coastal sites.
