WATERSHED-BASED PLAN

Shawsheen River Watershed

February 26, 2025

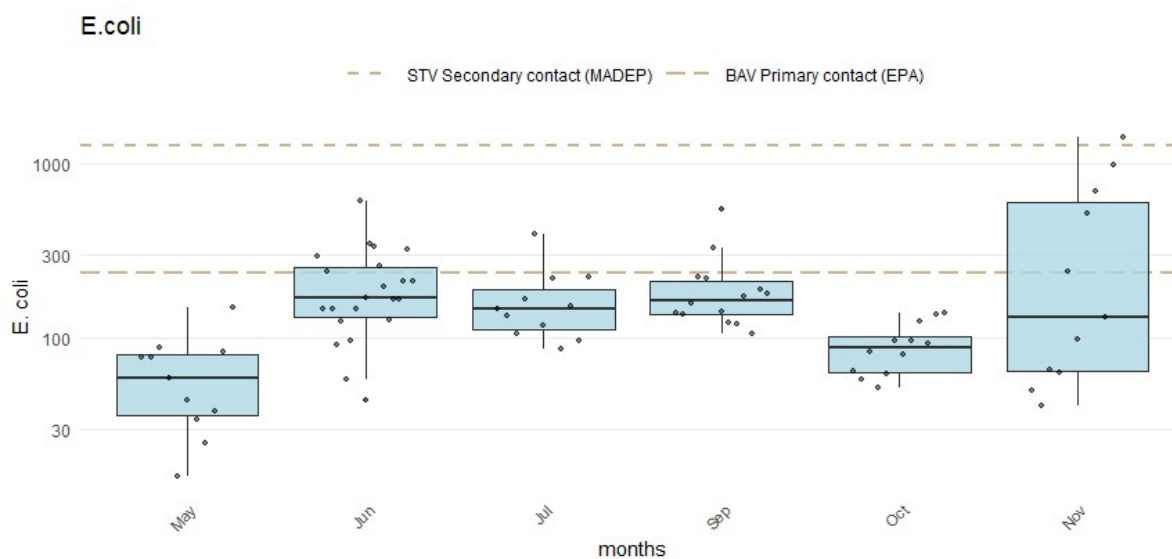
Figure 2: Boxplots displaying the average concentration of *Escherichia coli* by sampling site, including Primary and Secondary recreational contact limits.

Figure 3: Boxplots displaying the average concentration of *Escherichia coli* in the sampling area of the Shawsheen by month, including Primary and Secondary recreational contact limits.

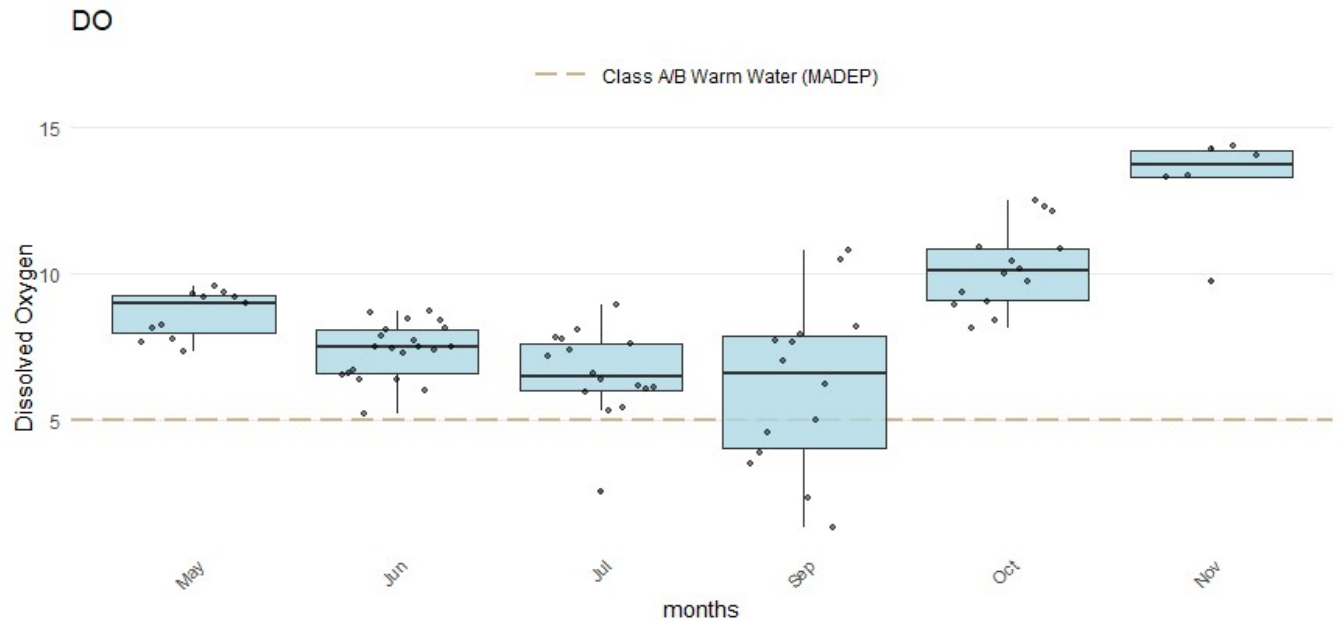
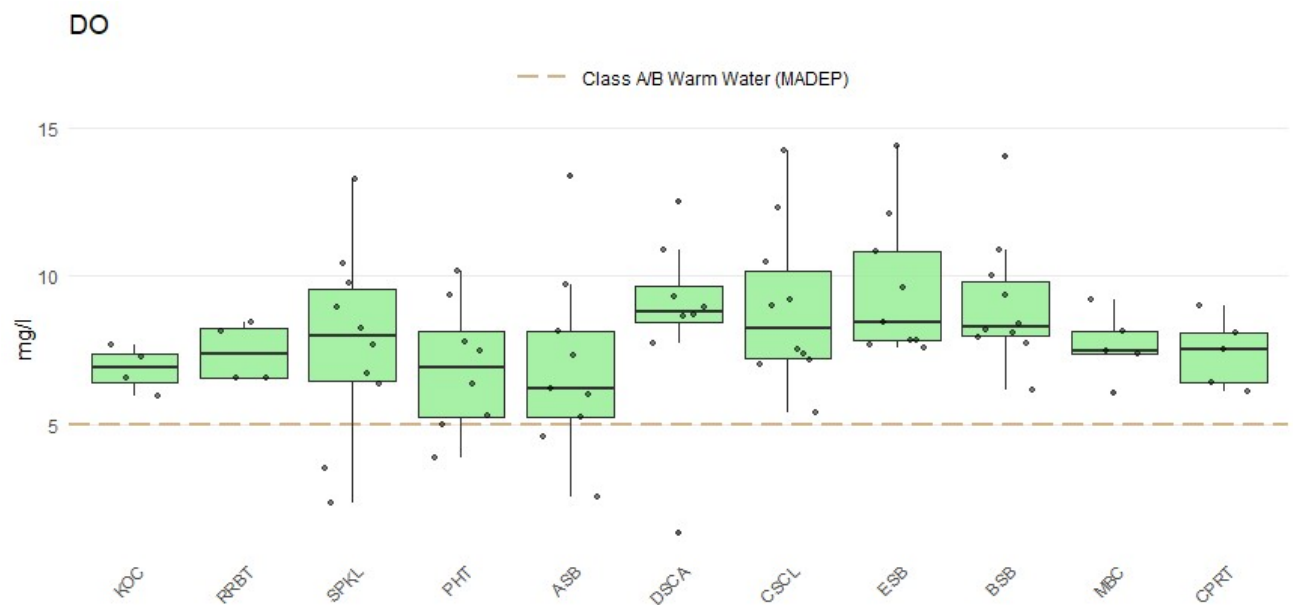
Figure 5: Boxplots displaying the average Dissolved Oxygen content by month in Milligrams per Liter, including the lower limit of dissolved oxygen readings to fall within the MADEP Warm Water Fisheries designation.

Figure 6: Boxplots displaying the average Dissolved Oxygen content by sampling site in Milligrams per Liter, including the lower limit of dissolved oxygen readings to fall within the MADEP Warm Water Fisheries designation.

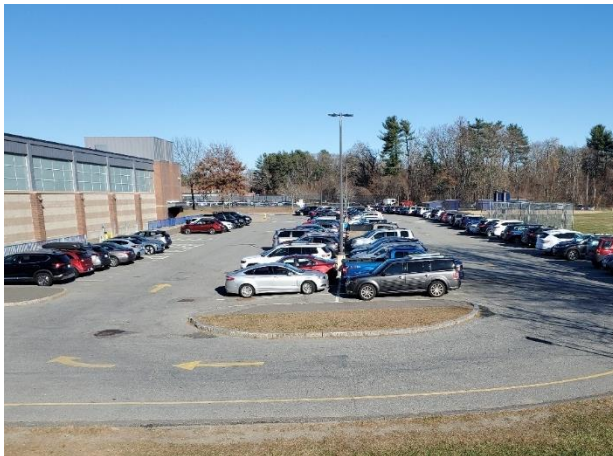
Our team observed many roofs, parking lots, and roads that drain to wetlands or streams without stormwater treatment before discharge, and many parking lots and roads that lack trees.

Parking lot at Andover High School

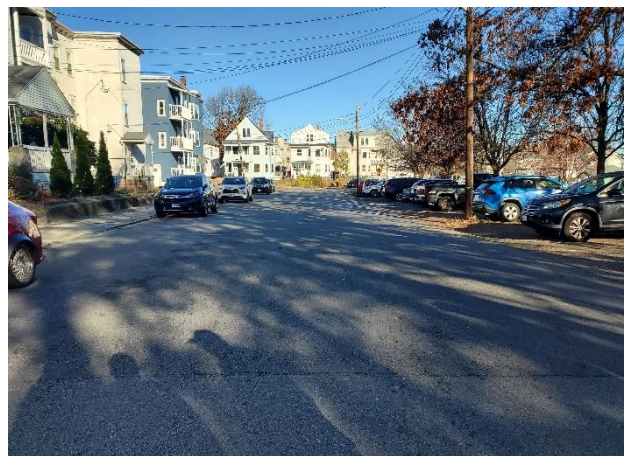
Shawsheen Road, Lawrence

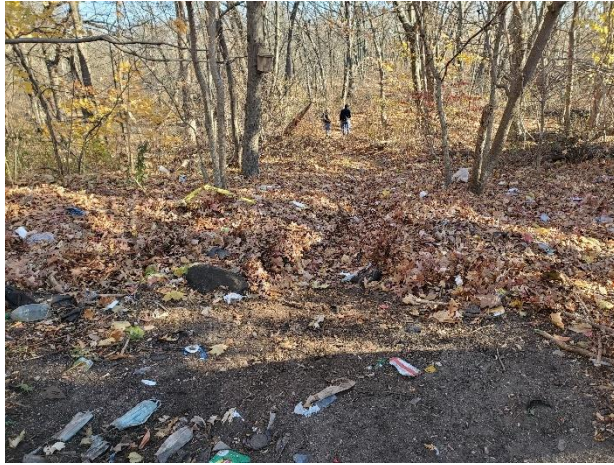
Our team observed dog waste and litter in Costello Park, and significant litter and debris in the riverfront zone along Shawsheen Road in Lawrence. We also observed many locations with degraded habitat and invasive species within stream buffers and wetlands.

Trash mixed with leaves above the Shawsheen River near South Lawrence East Elementary School

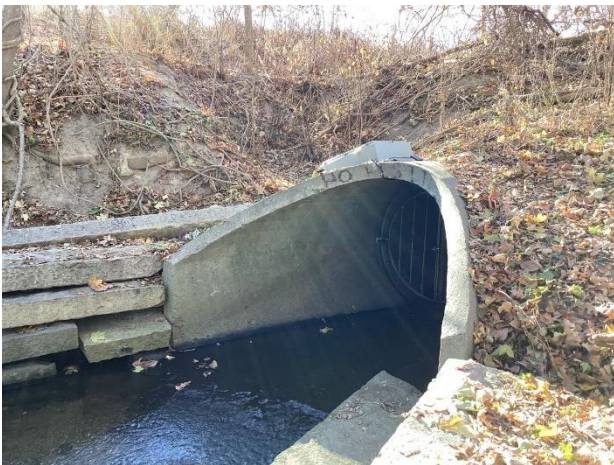
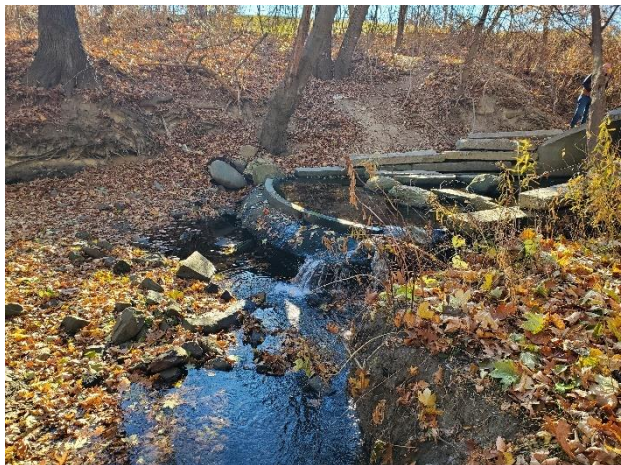
Our team observed erosion at a 60-inch outfall and along the downstream channel leading to the Shawsheen River, near South Lawrence East Elementary School.

Erosion at 60-inch outfall to Shawsheen River in Lawrence

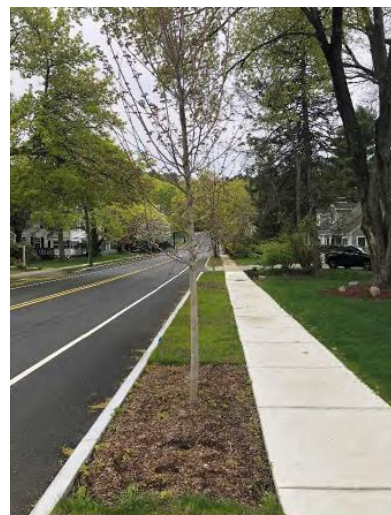
Streetscape infiltration tree
trench
