PREPARED FOR: CITY OF METHUEN

BLOODY BROOK WATERSHED PLANNING STUDY Methuen, Massachusetts

PARE CORPORATION
10 LINCOLN ROAD, SUITE 210
FOXBORO, MASSACHUSETTS 02035

SUBMITTED JUNE 2022

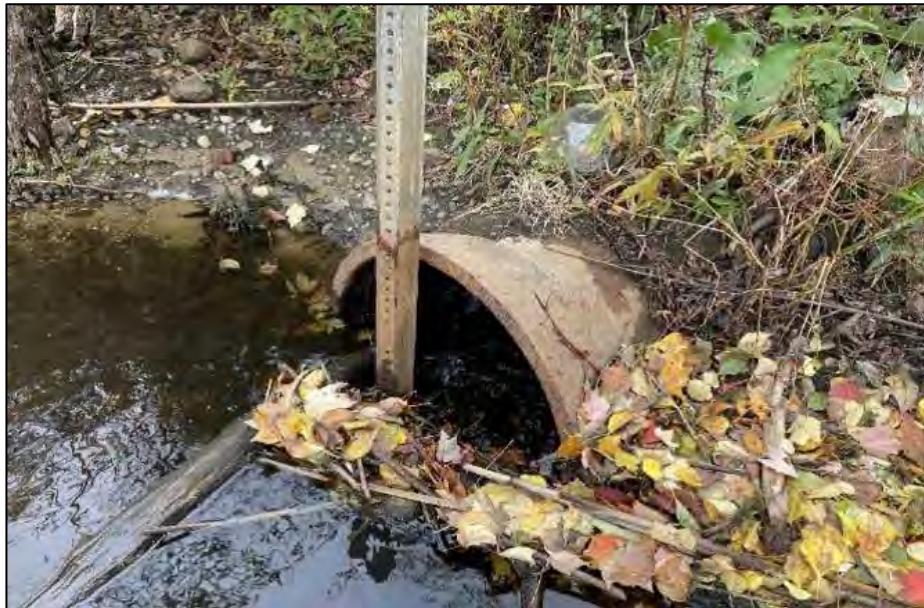
Photo No. 2.: Searles Pond Dam Low-Level Outlet Upstream End. Note Debris Accumulation at Approach.

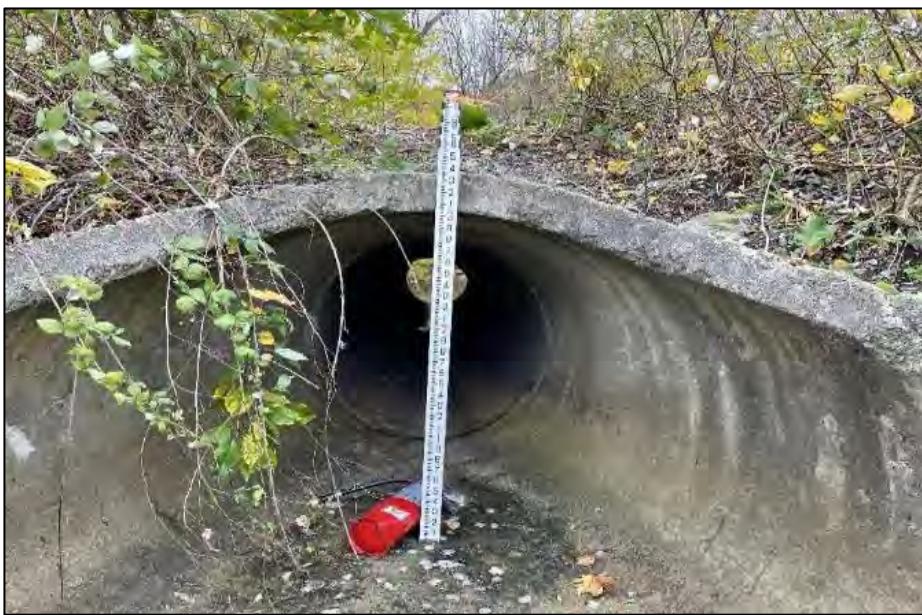
Photo No. 3.: Searles Pond Dam Spillway Upstream End. Generally clear of debris.

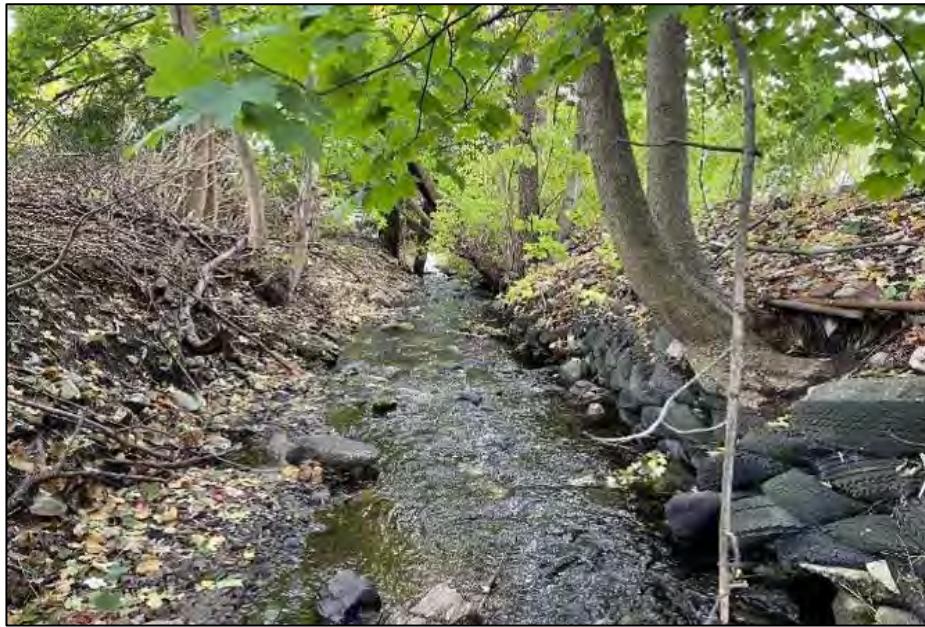
Photo No. 8.: Brooks Street – East Street Channel. Open Channel at 1/2 of the length from Brooks Street looking downstream. Note bare banks prone to erosion and rubber tire retaining wall.

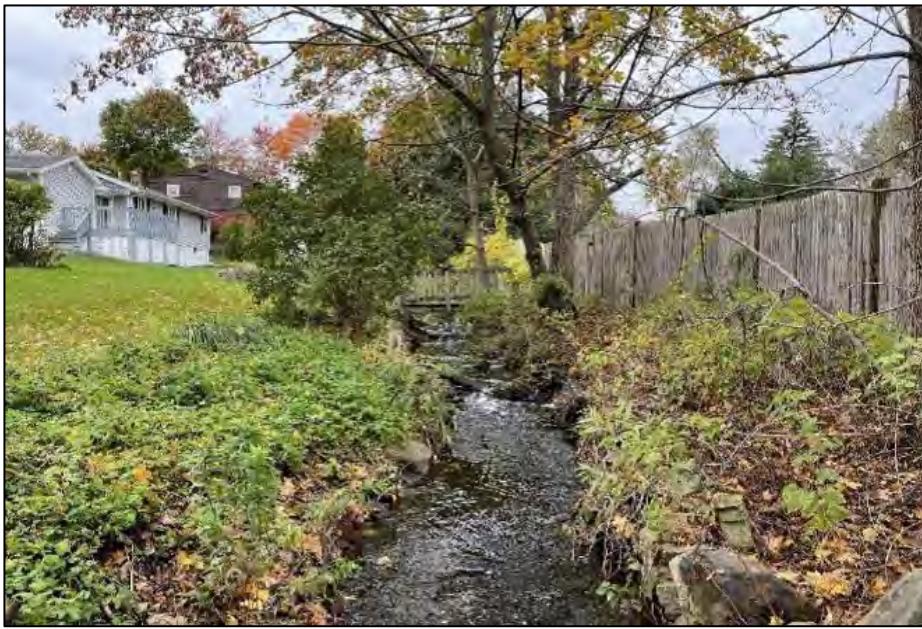
Photo No. 9.: Brooks Street – East Street Channel. Open Channel at 2/3 of the length from Brooks Street – looking upstream.

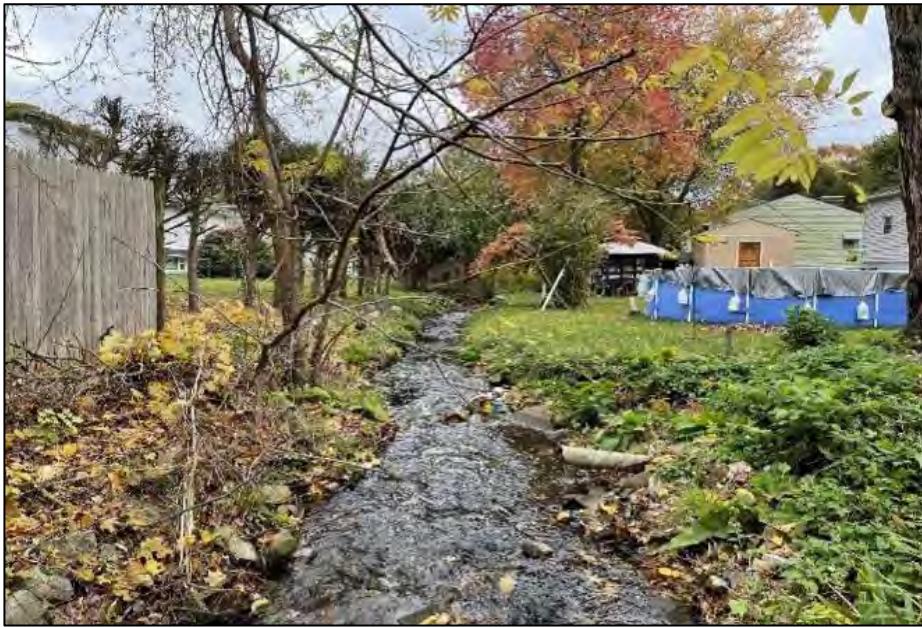
Photo No. 10.: Brooks Street – East Street Channel. Open Channel at 2/3 of the length from Brooks Street – looking downstream. Note limited freeboard (less than 2 feet) from stream bottom to adjacent residential property.

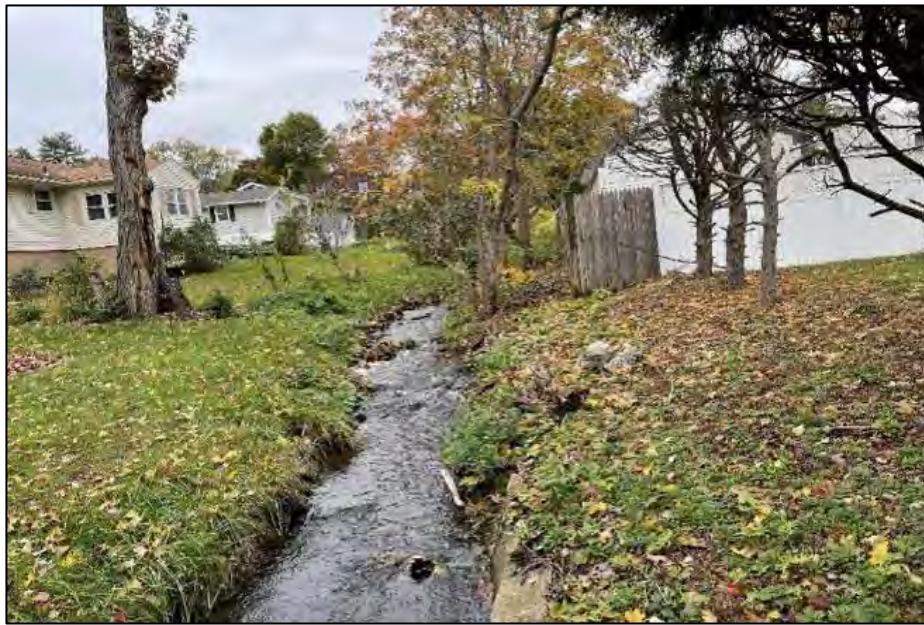
Photo No. 11.: Brooks Street – East Street Channel. Open Channel 100-ft away from Brooks Street – looking upstream. Note limited freeboard (less than 2 feet) from stream bottom to adjacent residential property.

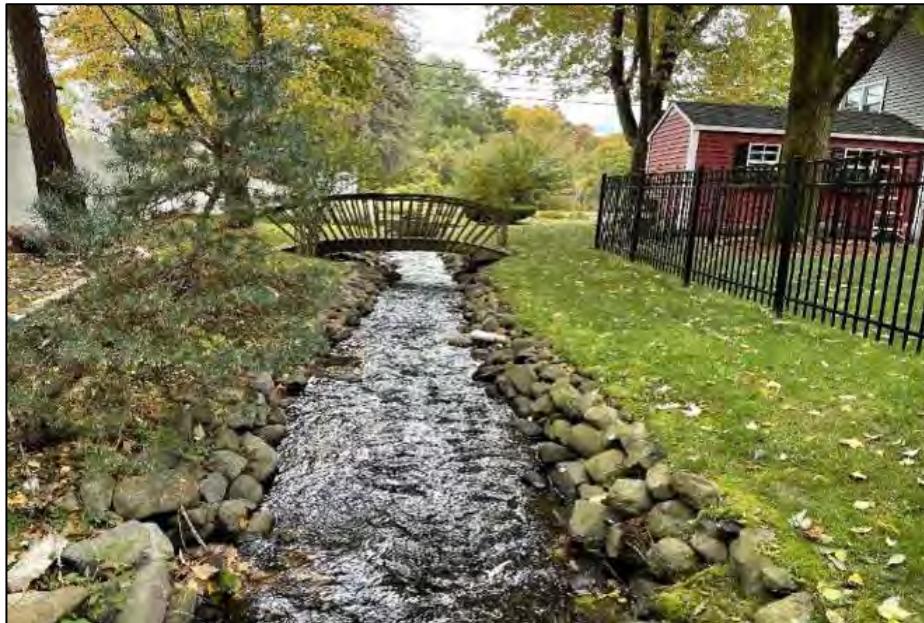
Photo No. 12.: Brooks Street – East Street Channel. Open Channel 100-ft away from Brooks Street – looking downstream. Note limited freeboard (less than 2 feet) from stream bottom to adjacent residential property.

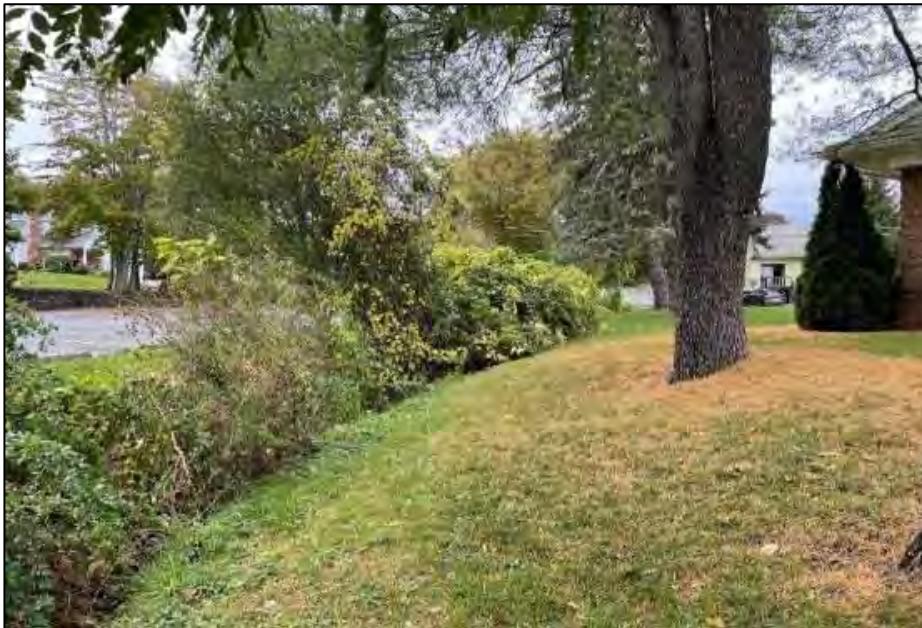
Photo No. 16.: Jehovah's Witness Parking Lot – Channel between East Street and Parking Lot looking Upstream.

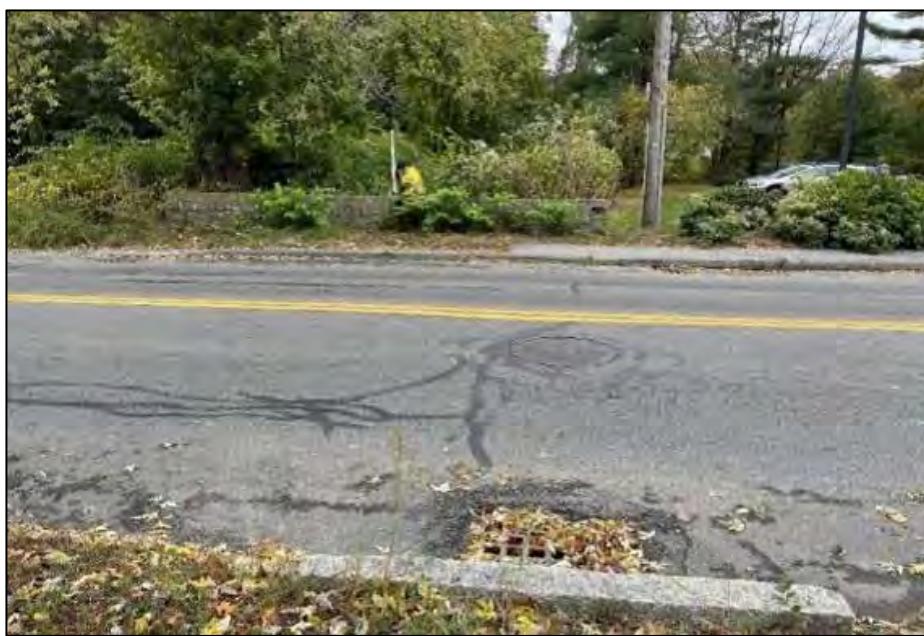
Photo No. 19.: Jackson Street – looking upstream.

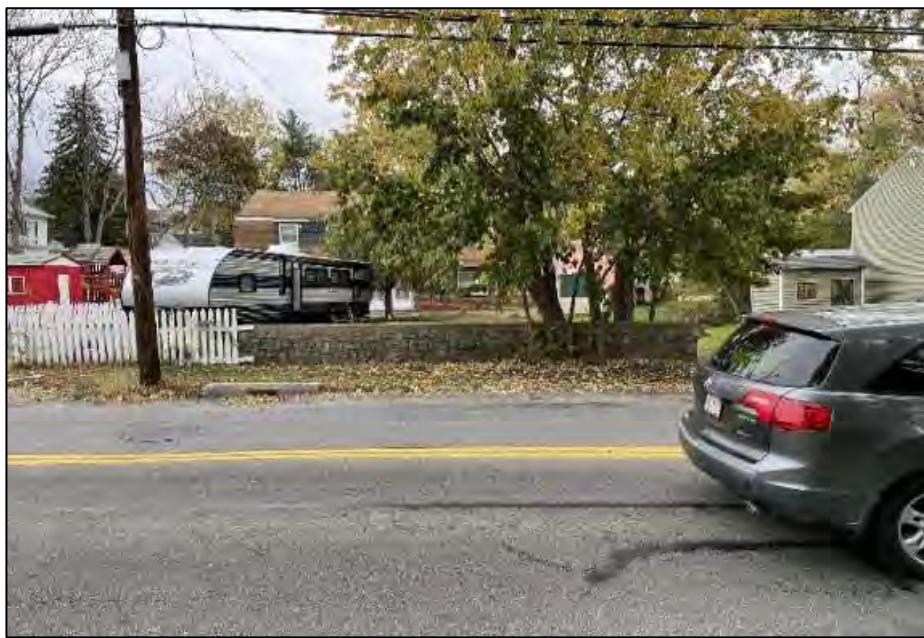
Photo No. 20.: Jackson Street – looking downstream

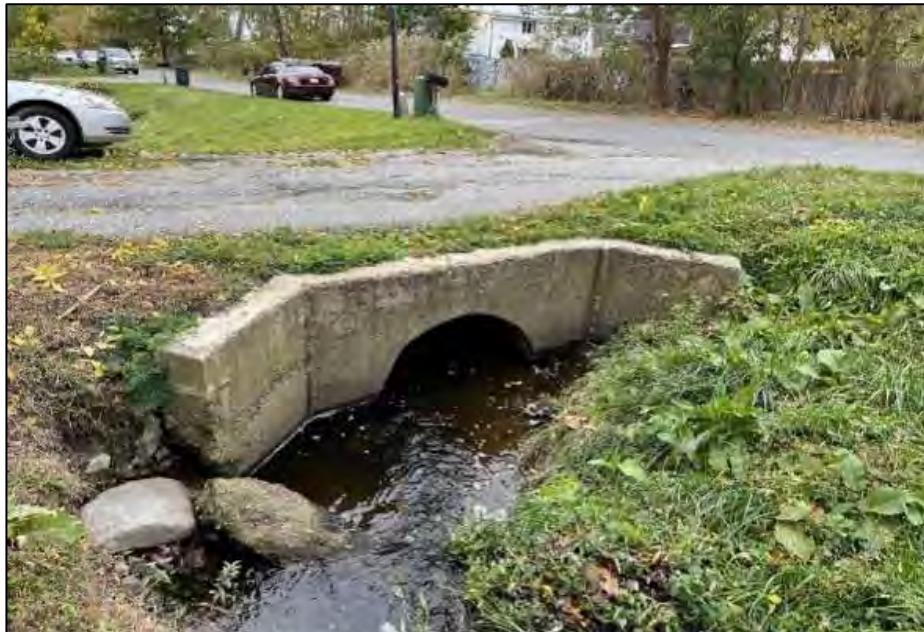
Photo No. 26.: Bicknell Avenue Culvert #2 – Upstream Invert.

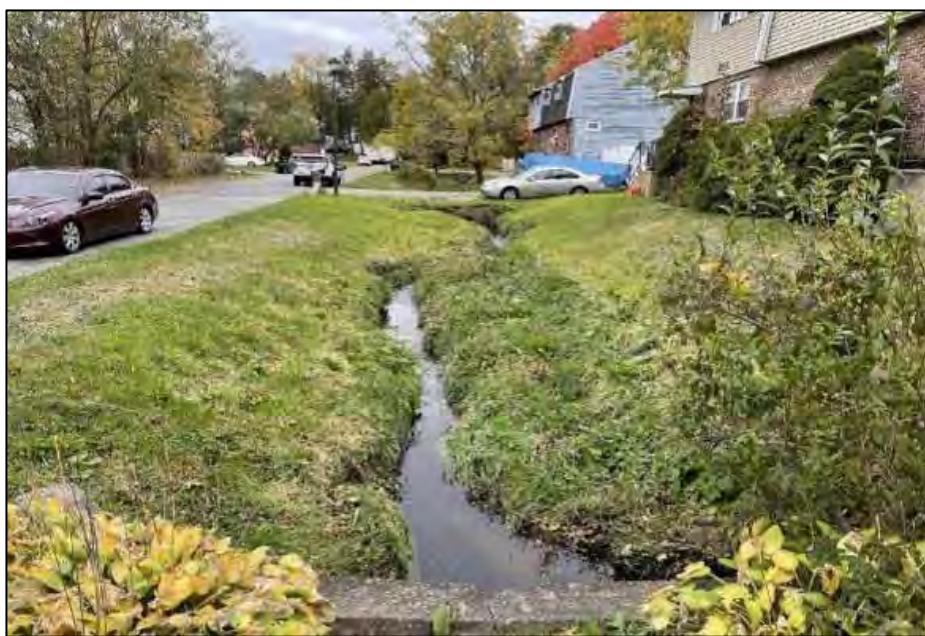
Photo No. 27.: Bicknell Avenue Culvert #2 – Bicknell Avenue Culvert #3 Channel looking upstream.

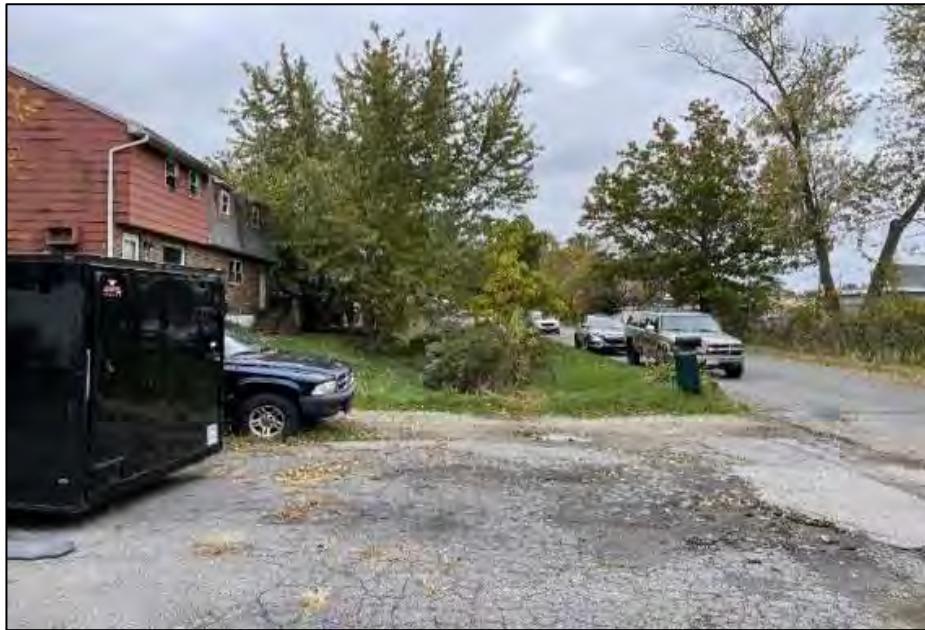
Photo No. 28.: Bicknell Avenue Culvert #3 looking downstream

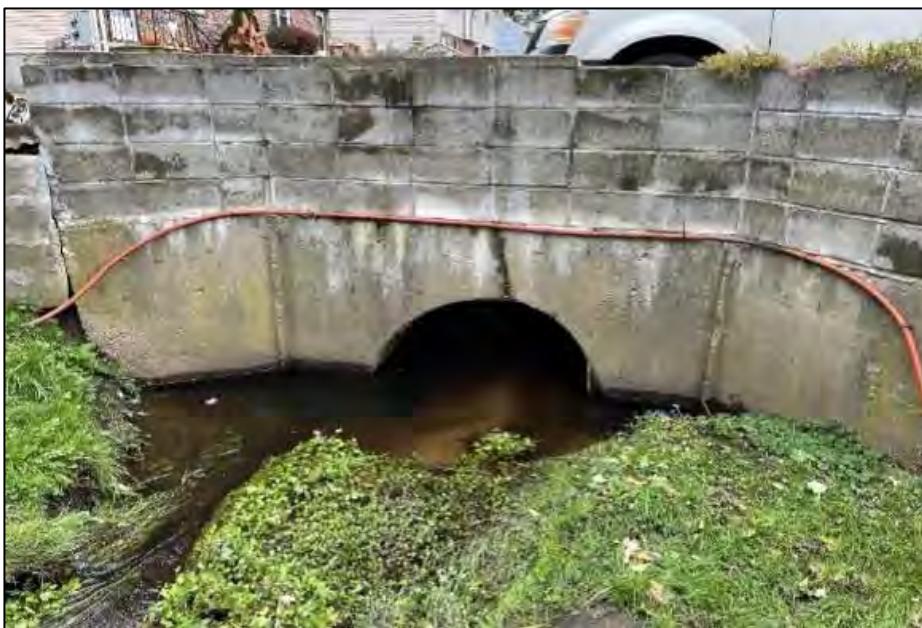
Photo No. 29.: Bicknell Avenue Culvert #4 upstream invert.

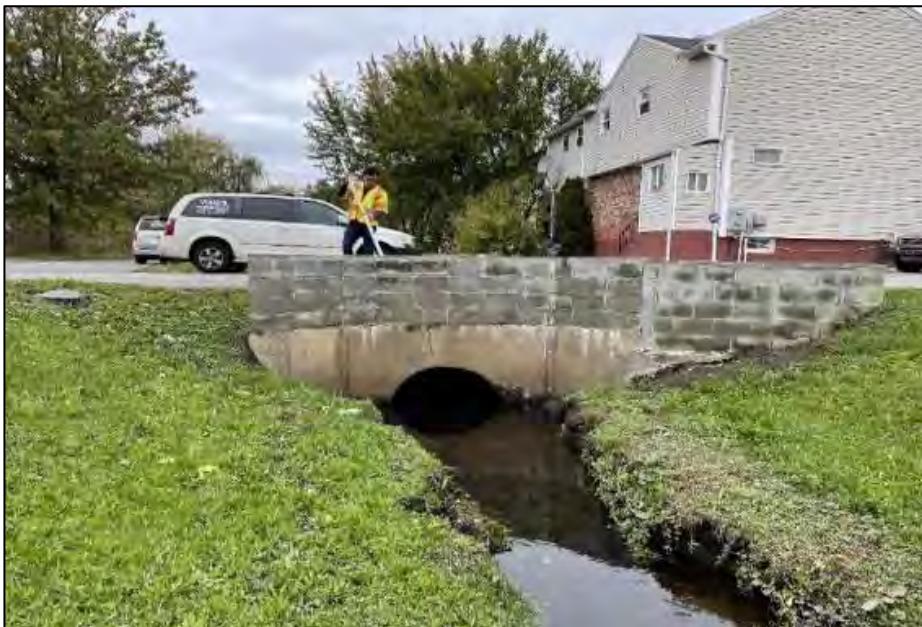
Photo No. 30.: Bicknell Avenue Culvert #4 downstream invert

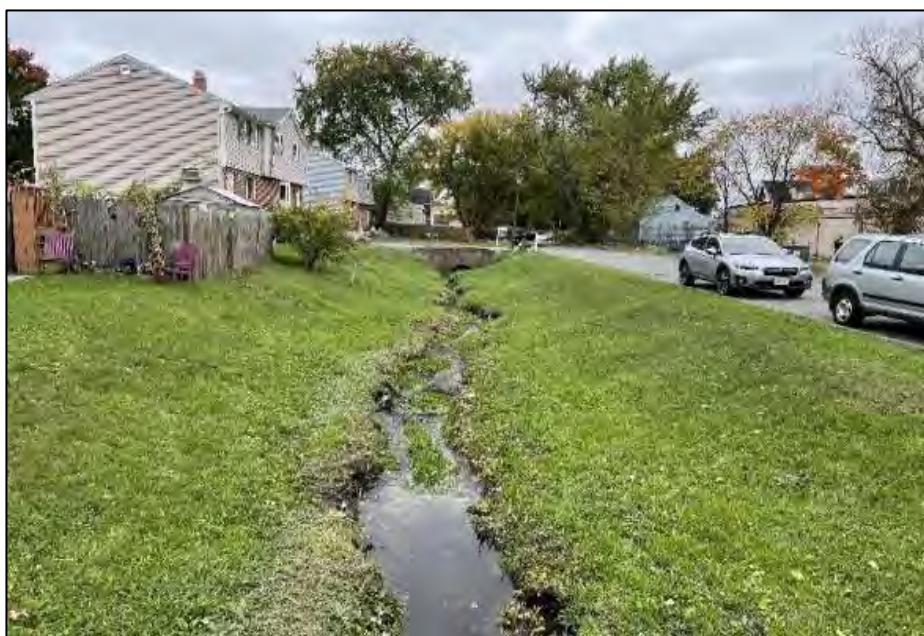
Photo No. 31.: Bicknell Avenue Culvert #4 – Bicknell Avenue Culvert #5 Channel looking upstream.

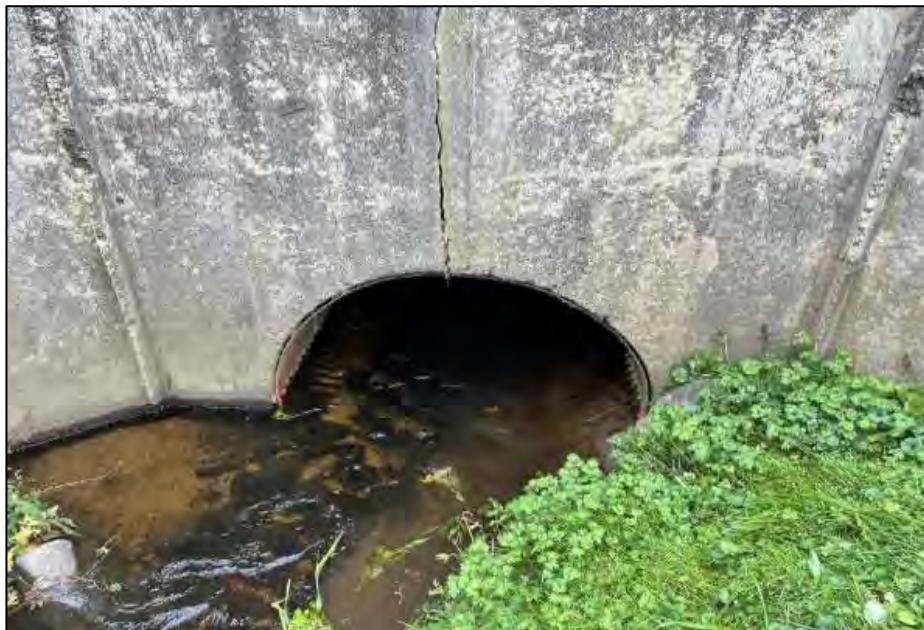
Photo No. 32.: Bicknell Avenue Culvert #5 upstream invert.

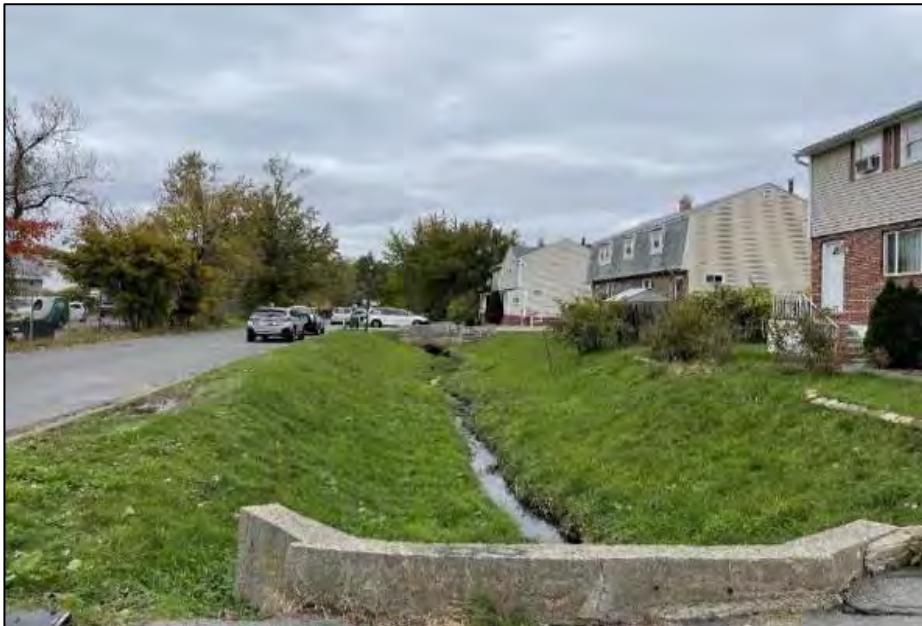
Photo No. 34.: Bicknell Avenue Culvert #4 – Bicknell Avenue Culvert #5 Channel looking upstream.

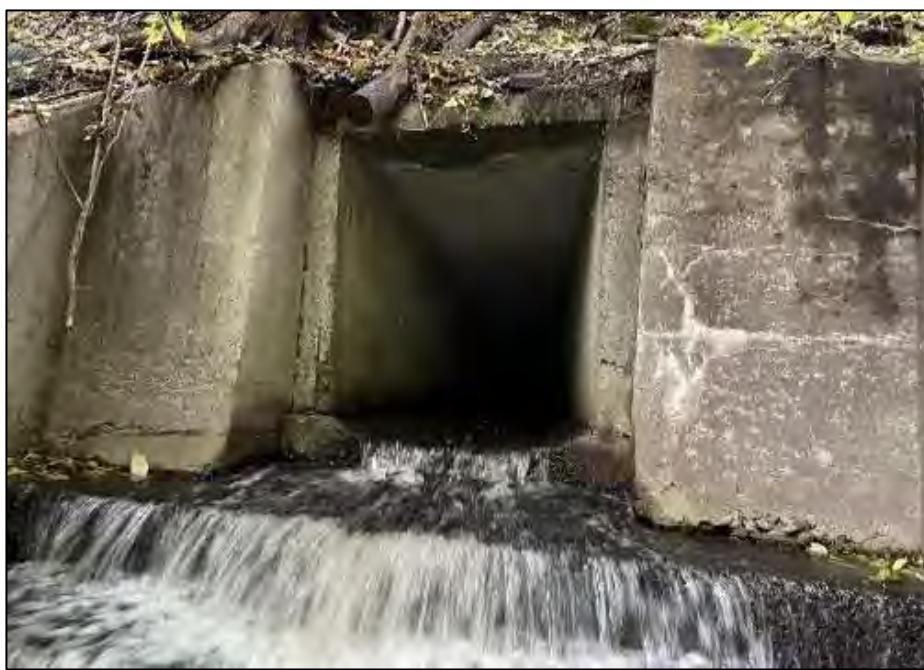
Photo No. 37.: Bloody Brook Culvert Outfall to Spicket River

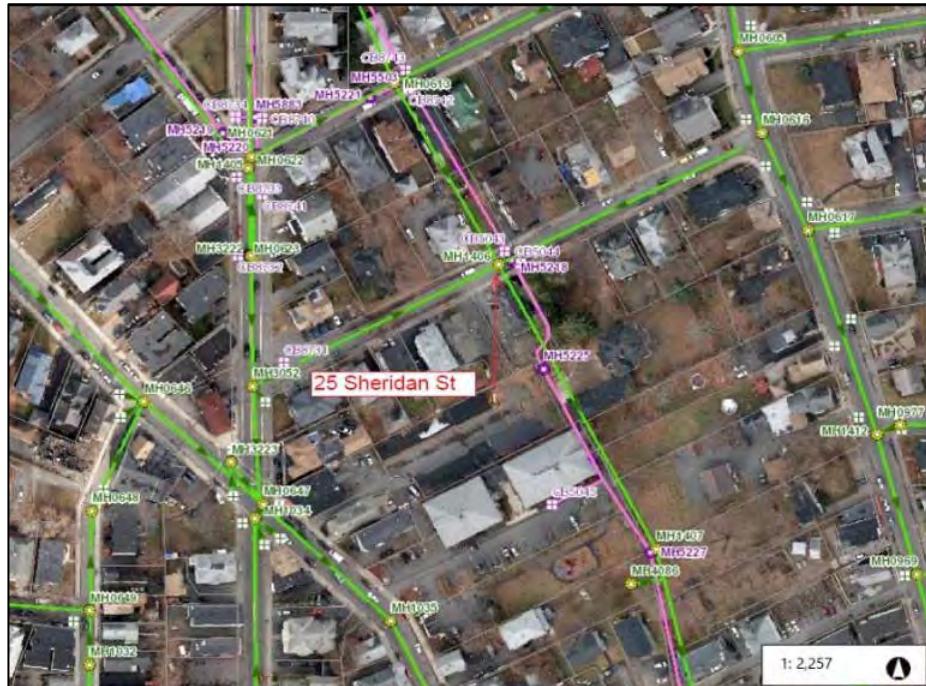
Photo No. 40.: Downstream Channel Path – Clip #3

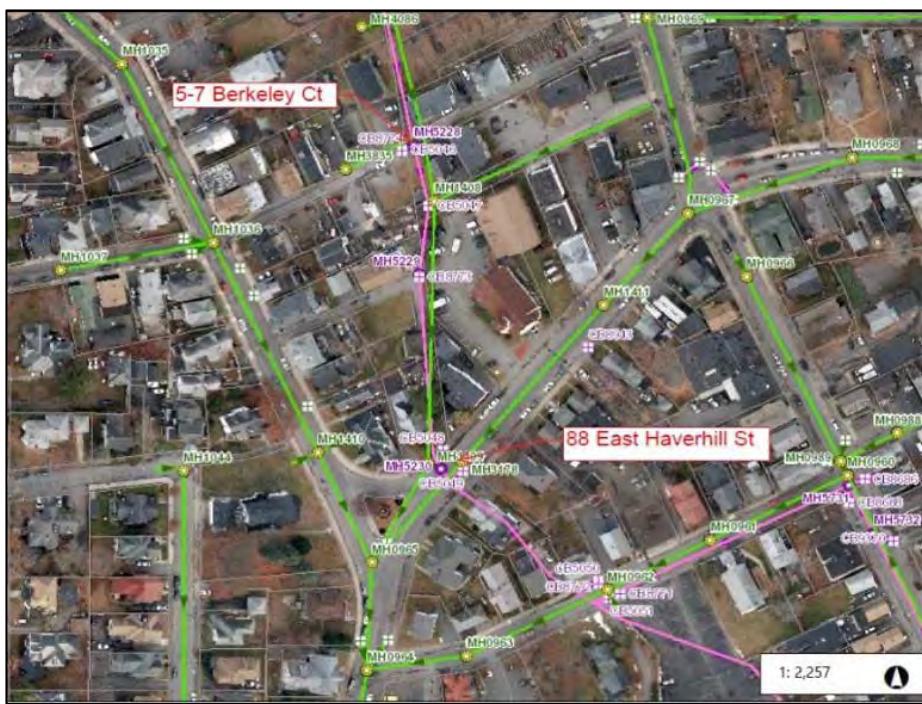
Photo No. 41.: Downstream Channel Path – Clip #4

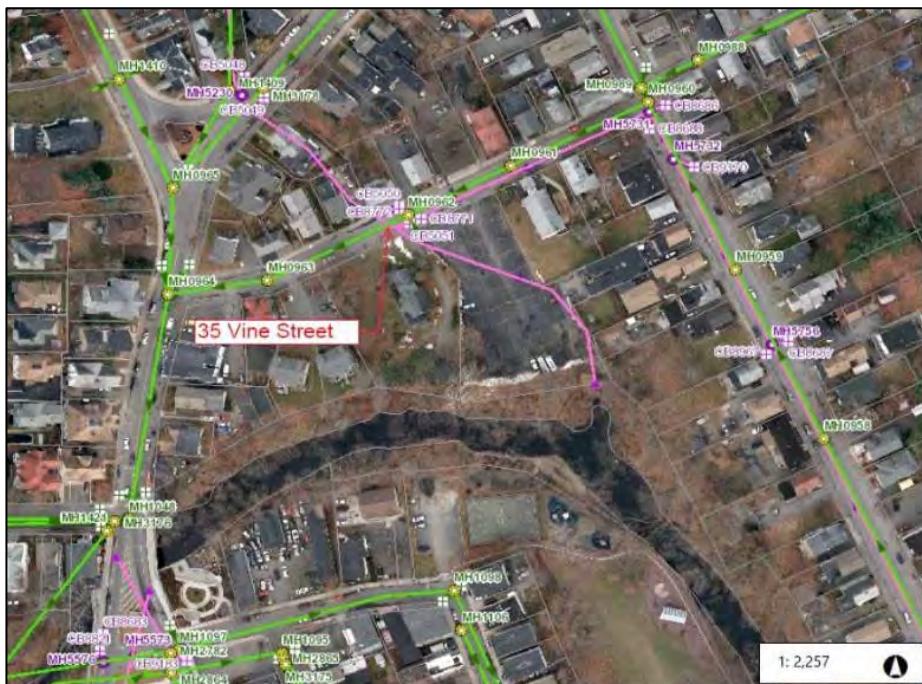
Photo No. 42.: Downstream Channel Path – Clip #5
